**GEOLOGICAL INVESTIGATION OF LAND
INSTABILITY BETWEEN KOHIMA AND ZHADIMA**

SUPONGTEMJEN

**DEPARTMENT OF GEOLOGY
NAGALAND UNIVERSITY**

October 2012

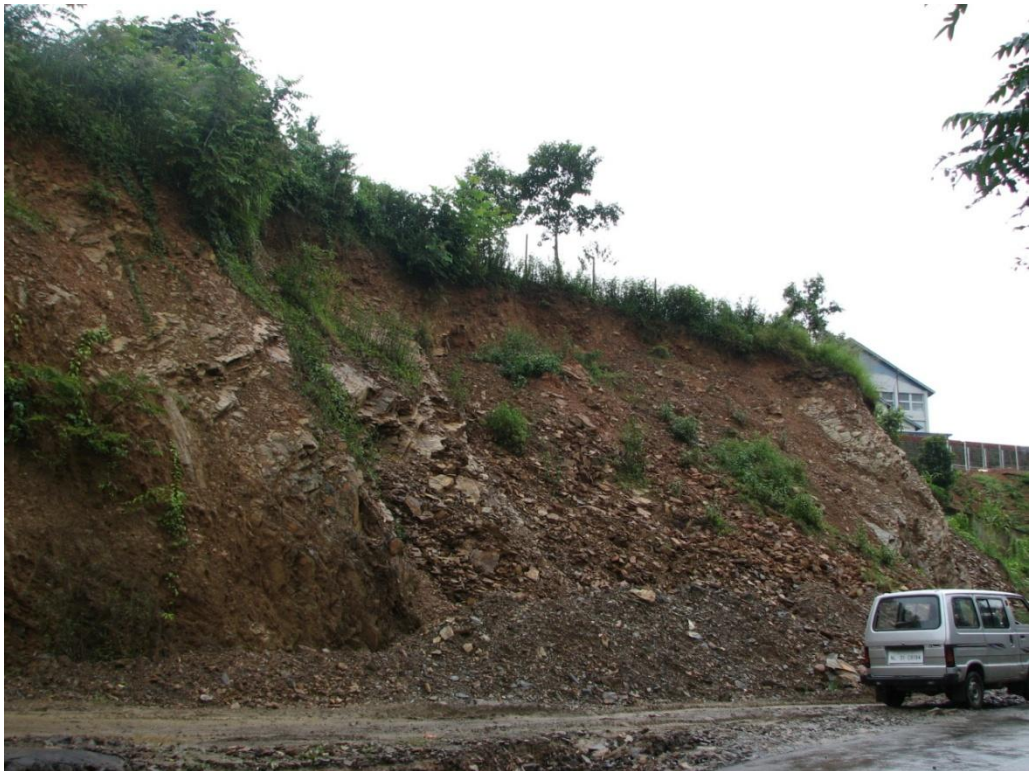
Plate 7.1b. Choked drain

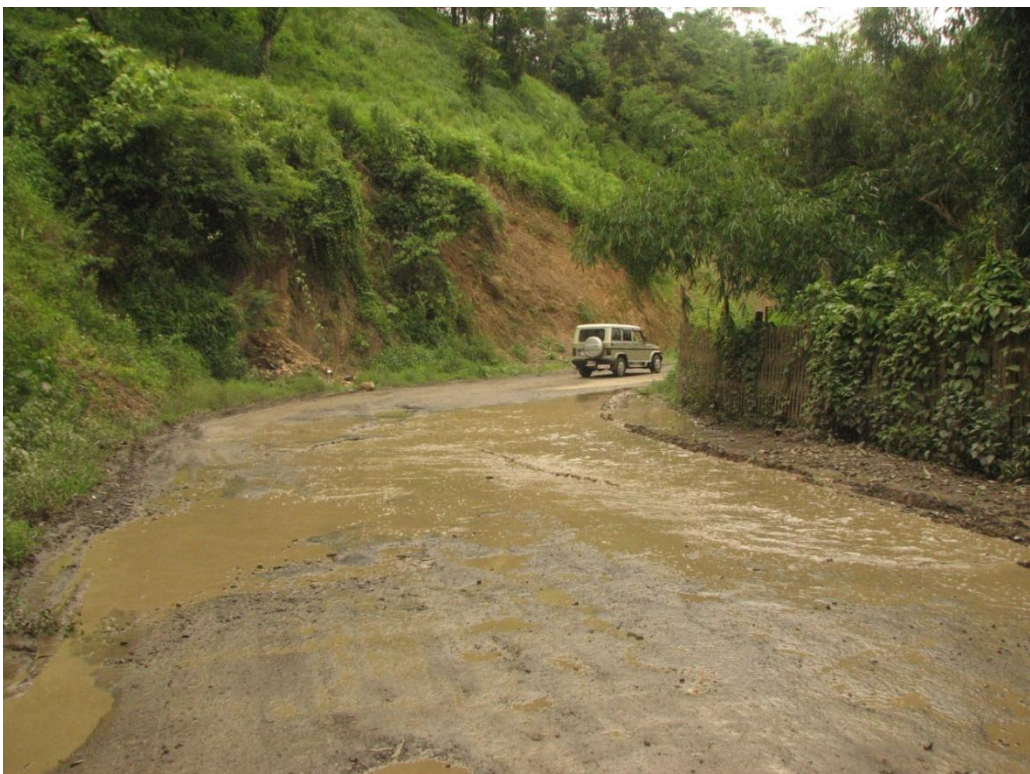
Plate 7.2b. Water logging during monsoon

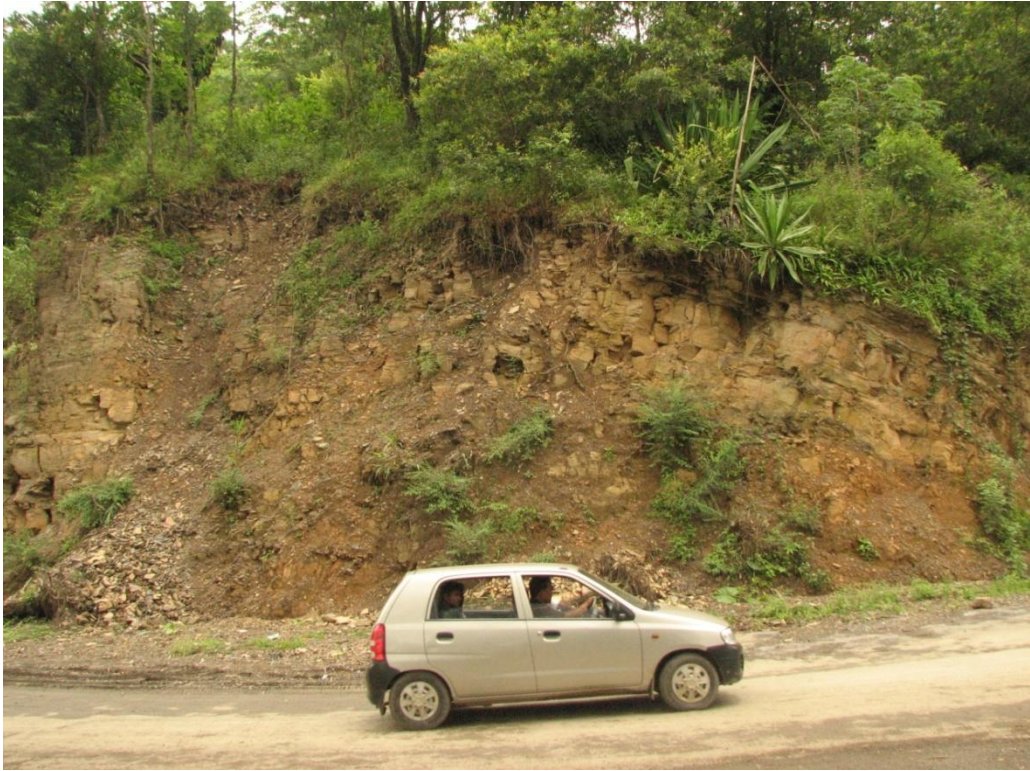
The rocks are jointed and fragmented due to which debris slides are a continuous phenomenon along this part of the highway. The bedrocks are covered with soil and debris. This is covered by trees on the upper portion of the slopes. The slope varies in

Plate 7.3a. Jointed and weathered shale

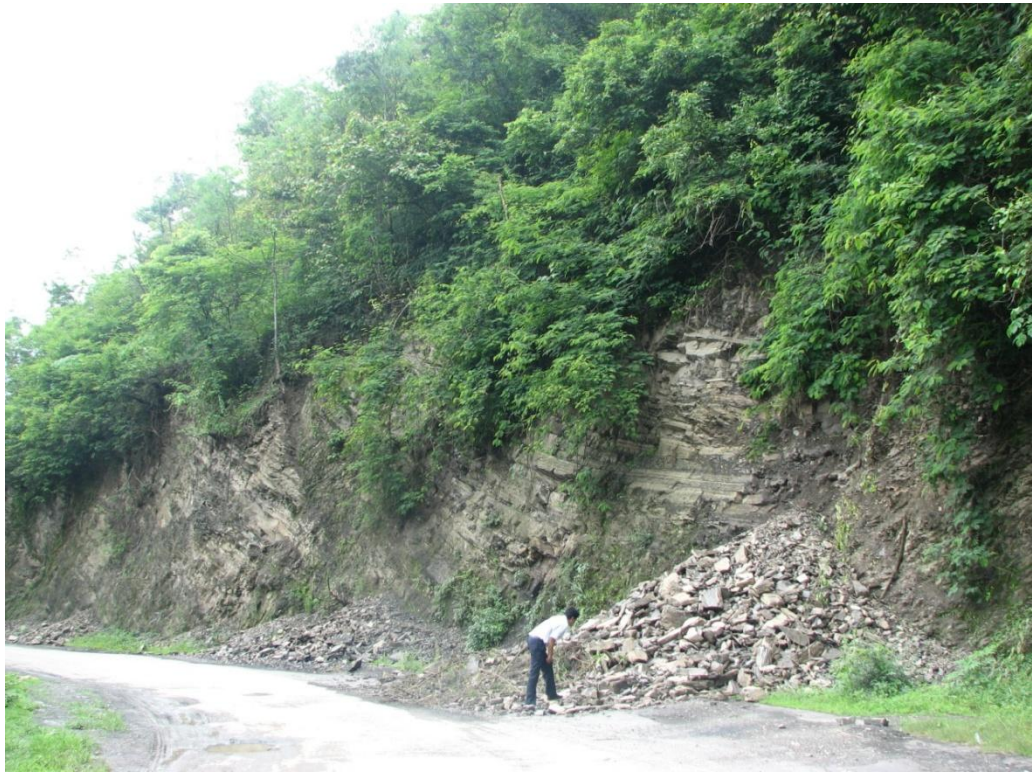
The rocks exposed in the area comprise jointed and fractured Disang shale intercalated with minor siltstone (Plate 7.4a) that are brown, buff, and gray in color. The bedrocks dip 70° towards 55°NE. A local fault striking N60°E and S240°W breaks the continuity of the beds (Plate 7.4b). The rocks exhibit three prominent sets of joints with varying trends. The first set of joints trends WNW-ESE with moderate dips towards SSW. The second set trends NW-SE with almost vertical dips towards SW. The third set trends NNE-SSW with near vertical dips towards the SE.

Plate 7.4a. Jointed and fractured rocks

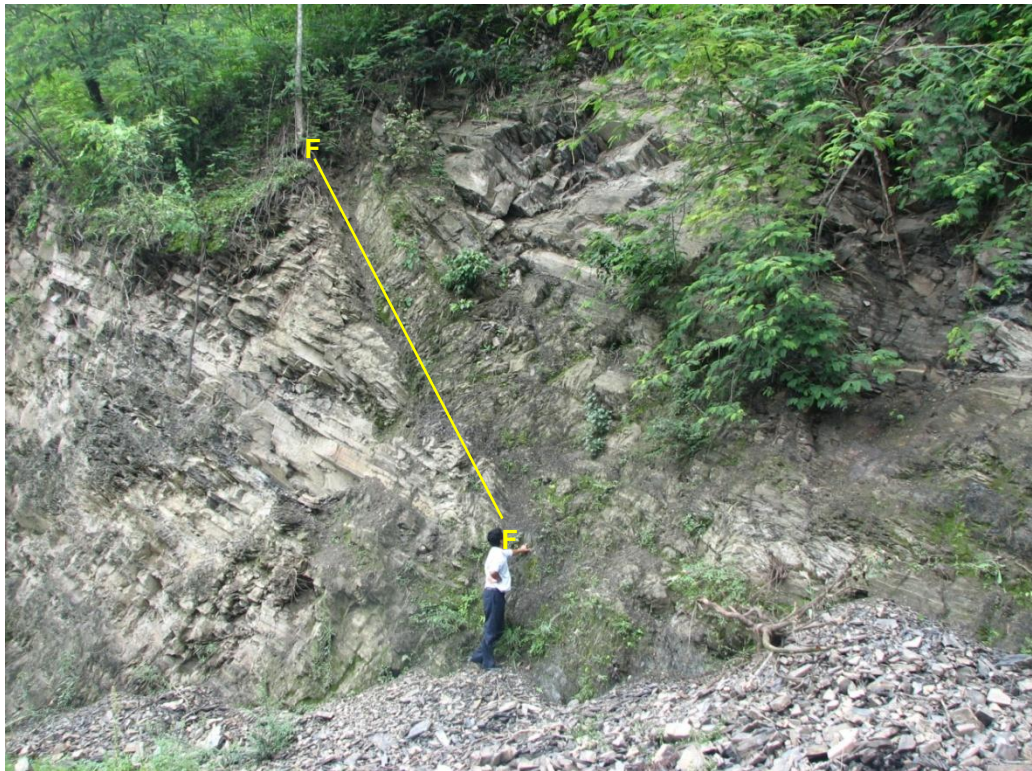
Plate 7.4b. Local fault in Disang

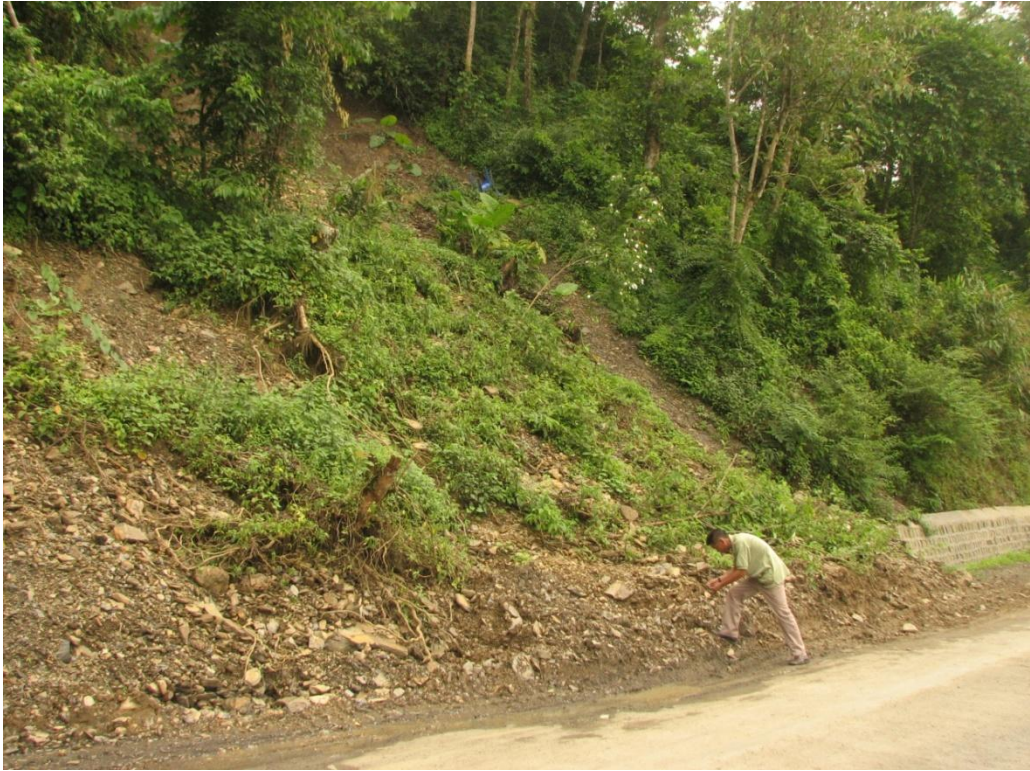
The Disang comprising abundant shale make up the rock type of this area. The rocks are highly crumpled and weathered due to which debris slides are common (Plate 7.5a). The shale is splintery and brown to dark gray in color. The bedrocks in the affected area are highly crumpled. Outcrops in the vicinity exhibit a number of joints dipping in various directions. Three prominent sets of joints with varying trends are noted. The first set trends WNW-ESE and dips 70° towards the SSW. The second set trends NW-SE with almost vertical dips towards the SW. The third set trends NE-SW and dips 33° towards the NW.

Plate 7.5a. Debris slide

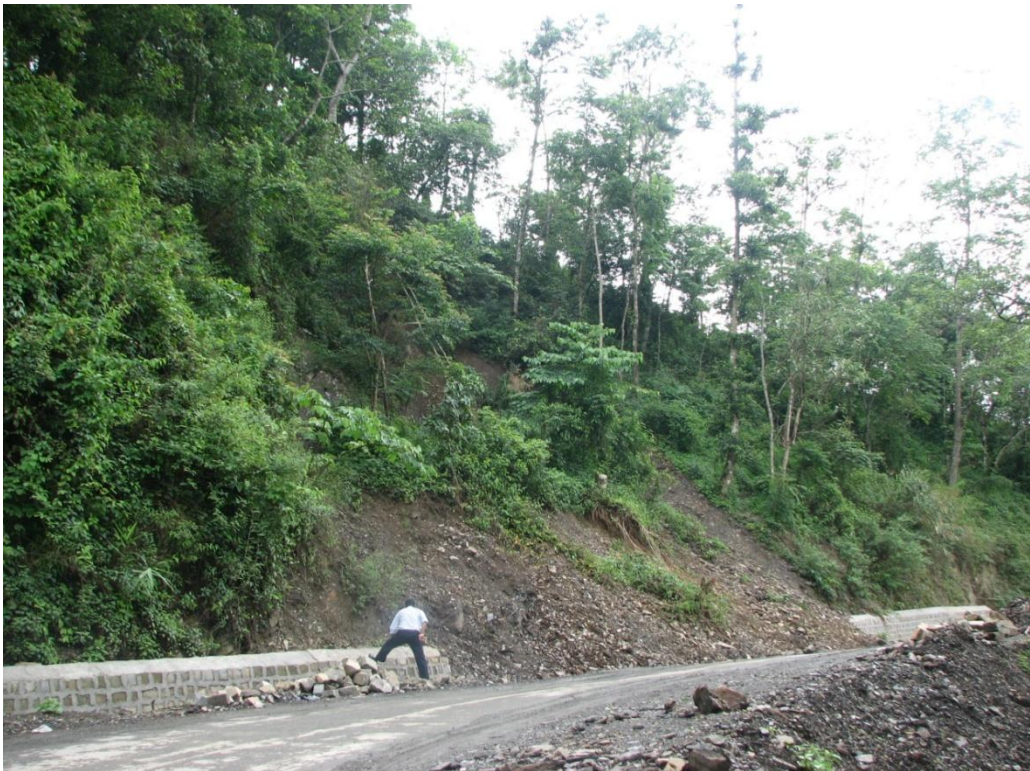
Plate 7.5b. Blocked roadside drain

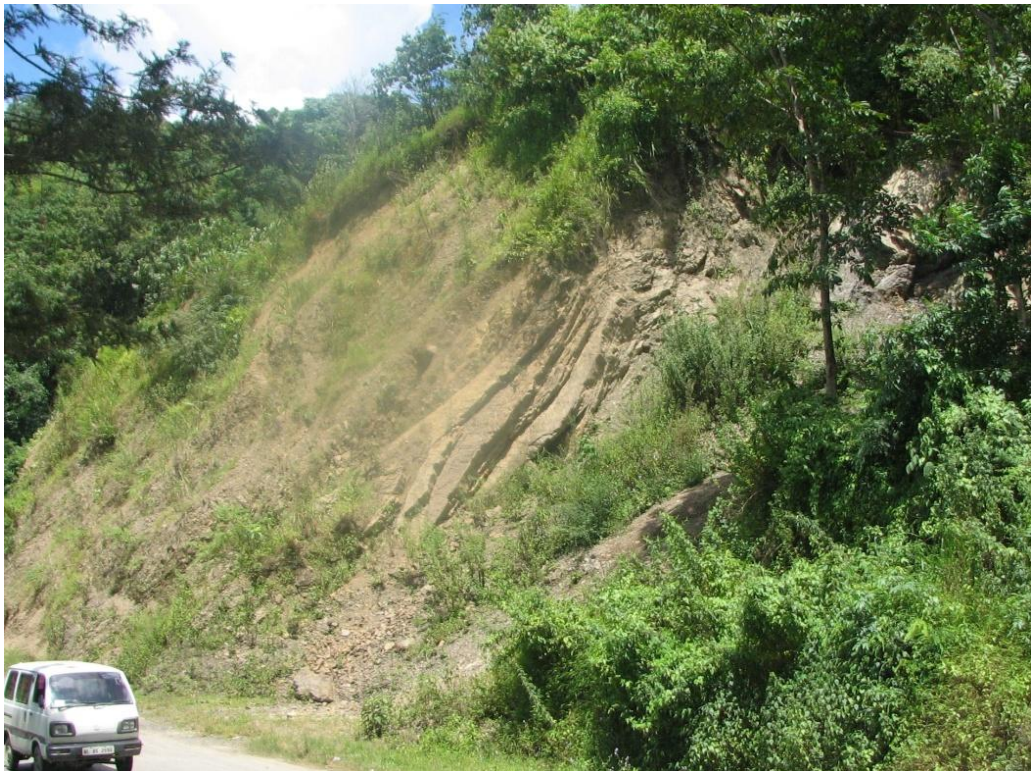
Plate 7.6b. Drainage blockage by debris

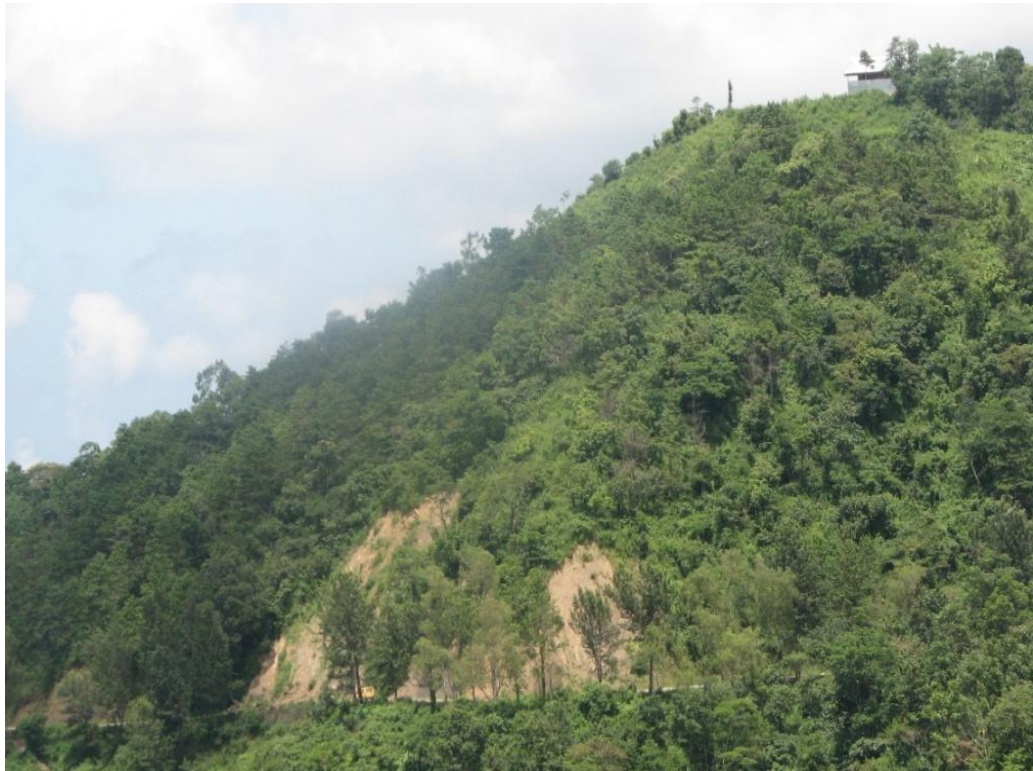
Plate 7.7a. View of debris slide scar

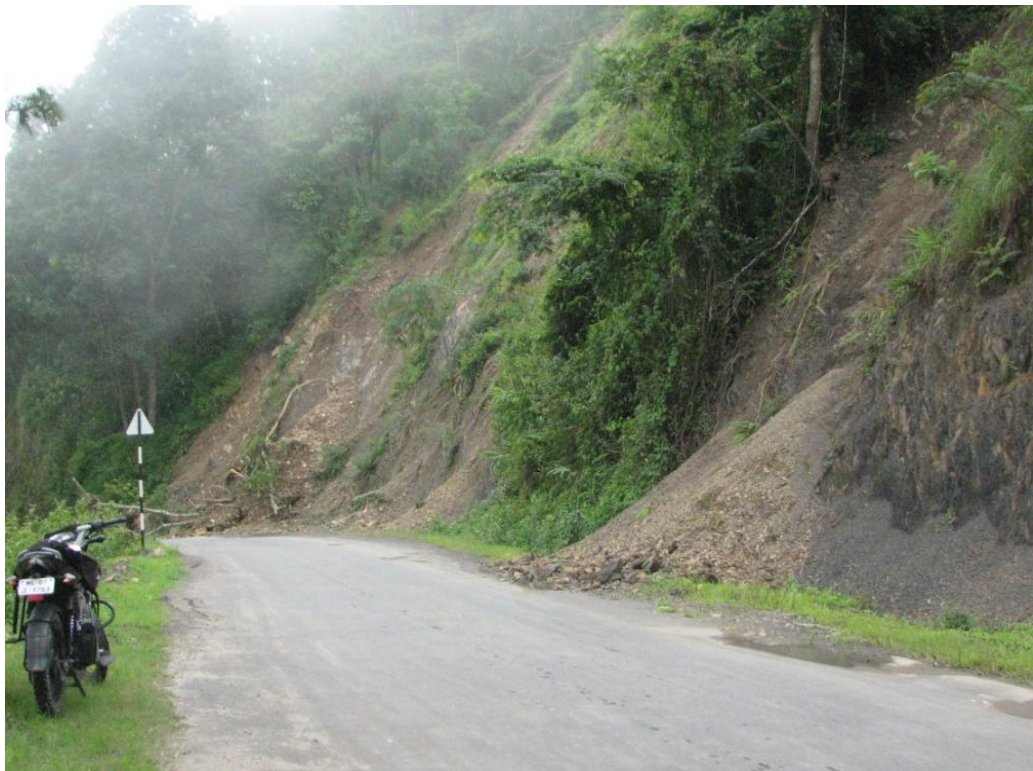
Plate 7.7b. Drain blocked by debris

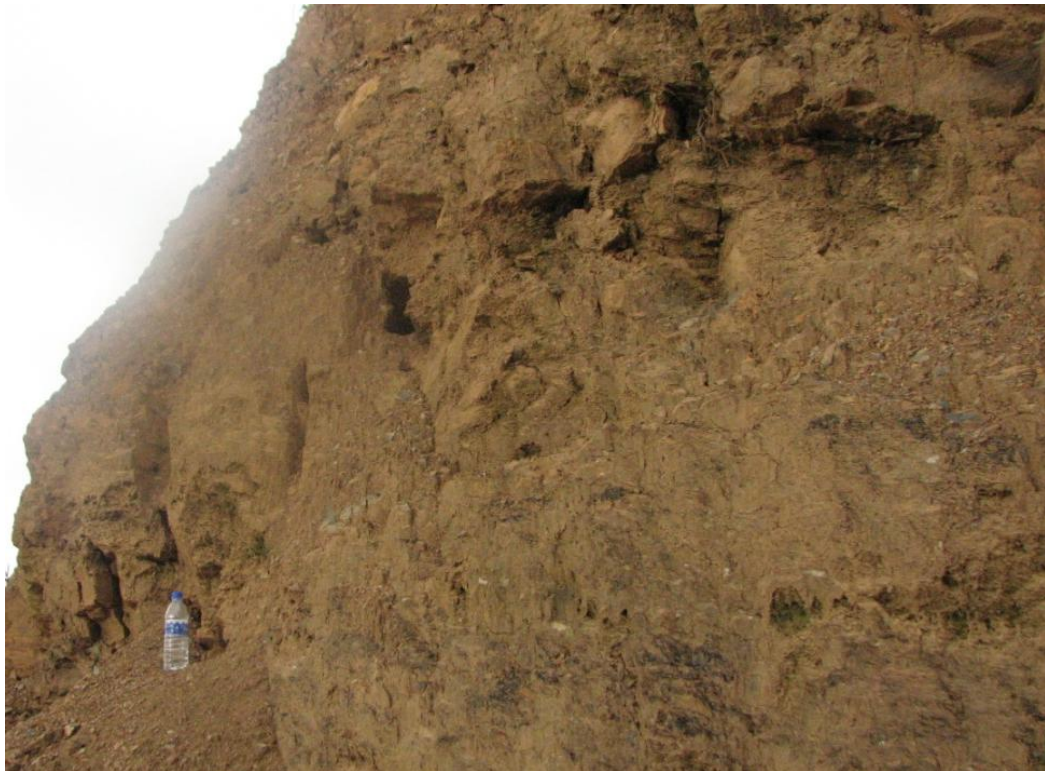
Plate 7.8b. Fissures in Disang shale

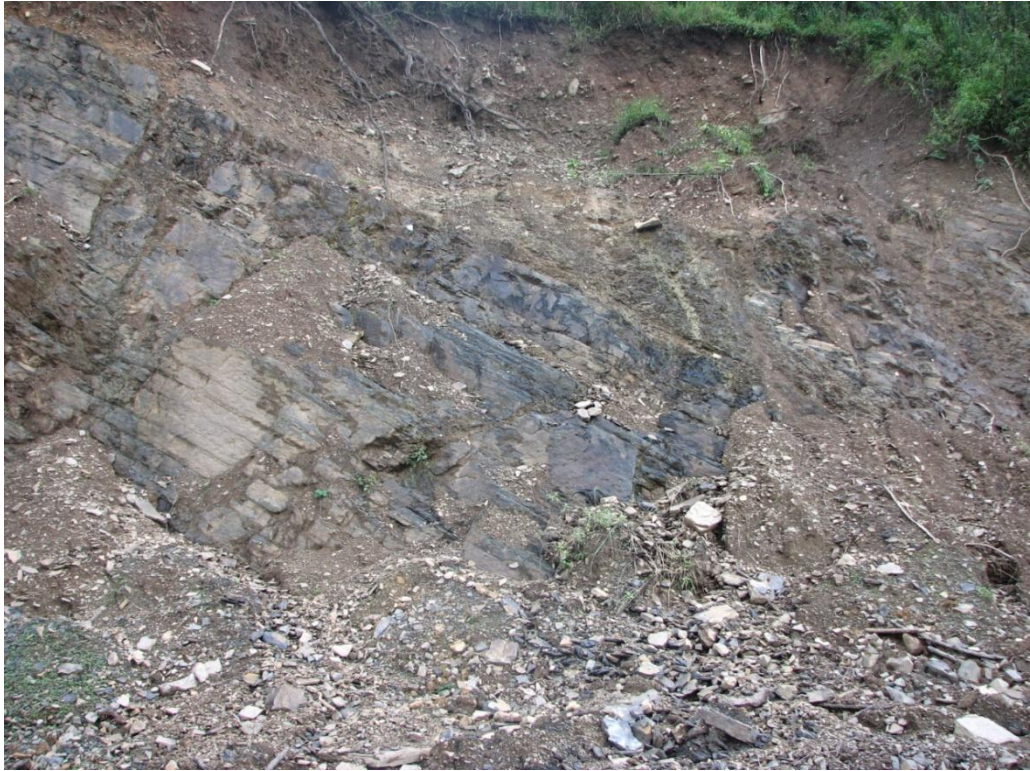
This area is made up of partially weathered shale capped by weak soil, the thickness of which ranges from 2 to 3 m (Plate 7.9a). The rocks are jointed, fragmented, and weathered due to which debris continuously slides downhill to block the roadside drain (Plate 7.9b). The bedrocks dip about 30° towards 135° SE. Three prominent sets of joints are noted. The first set of joints trends NW-SE dipping at angles of 45° towards SW. The second set trends N-S, dipping towards 270° W and the third set trends NNE-SSW, dipping 72° NNW.

Plate 7.9a. Partially weathered shale capped by weak soil

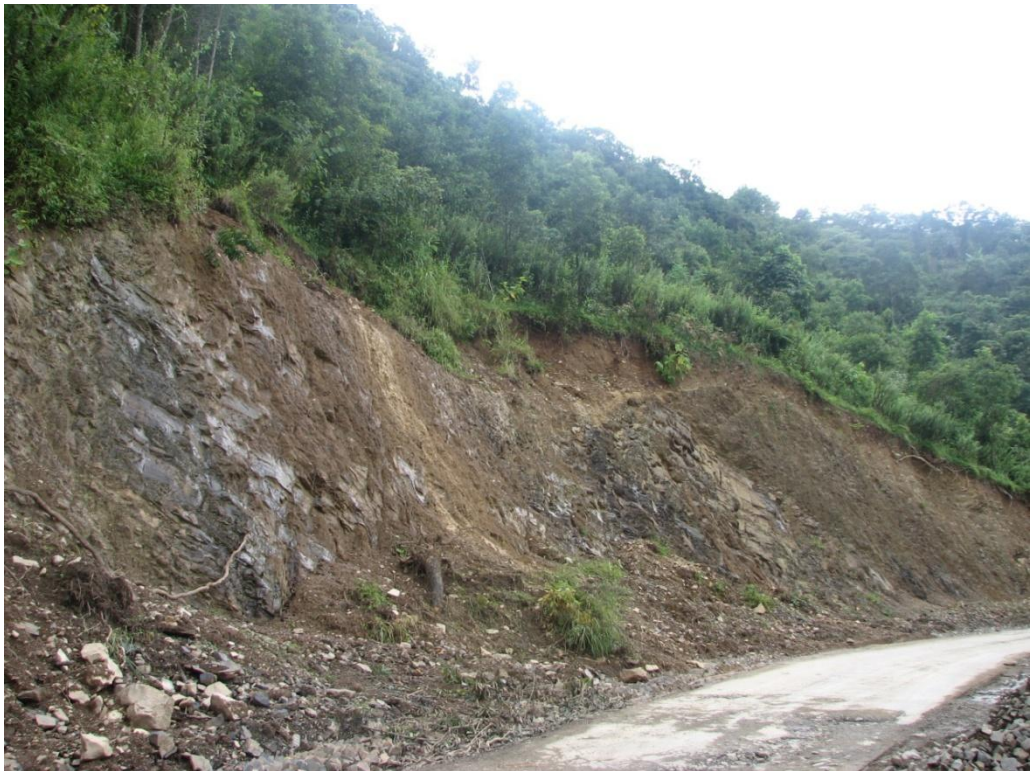
Plate 7.9b. Debris along the road section

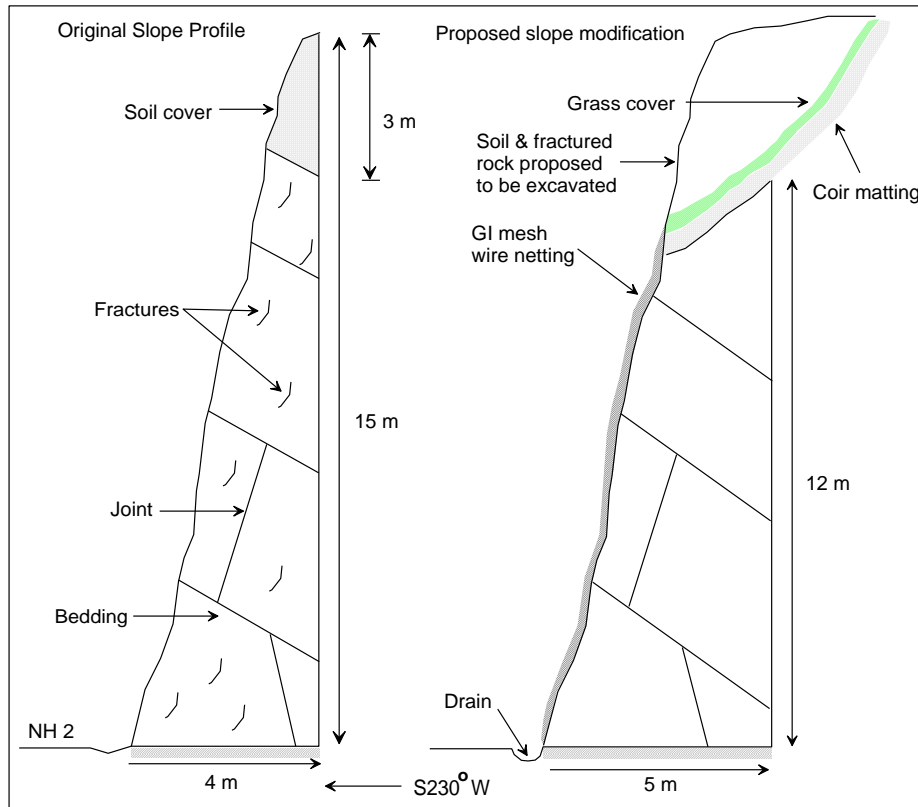
Fig. 7.9e. Proposed slope modification / mitigation measures

- i. Reduction of slope angle in the upper soil horizon and removal of 3 m of the top soil is recommended (Fig. 7.9e).
- ii. A geotextile cover and grass plantation on the excavated soil will greatly help.
- iii. About 100 m length of the rock section treated with GI wire netting will provide stability to the slope.
- iv. Proper roadside drainage and maintenance is necessary.

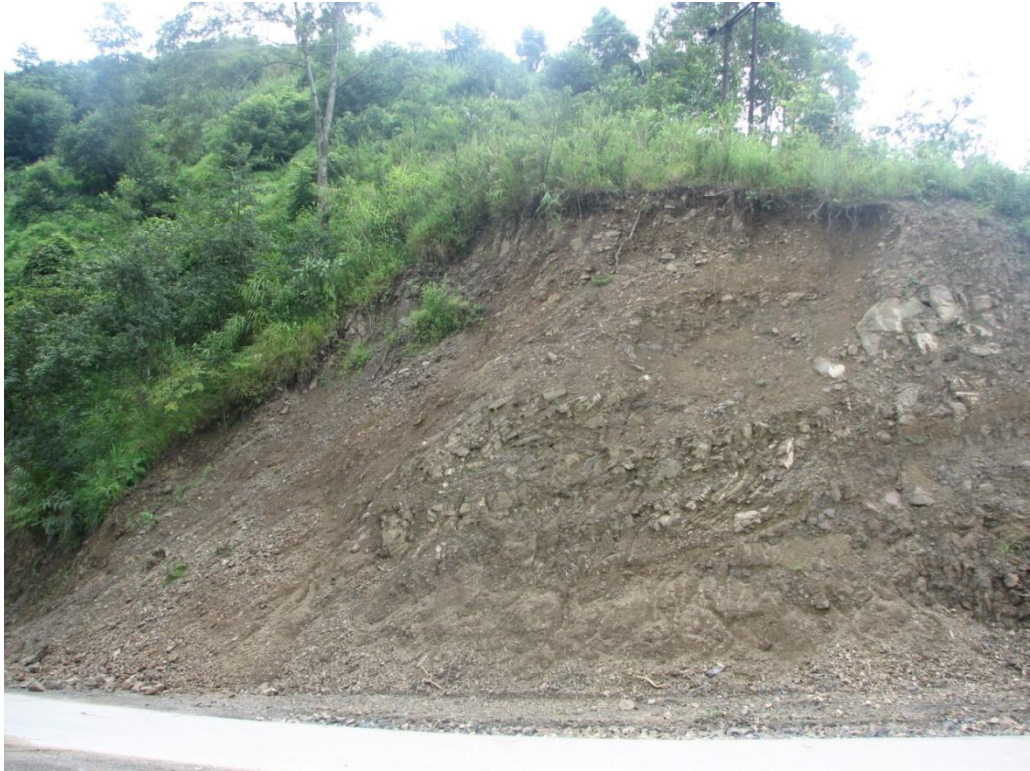
The cause of this instability is due to weak lithology on a high and steep slope with a gradient of 70°. This slope is approximately 10 m in height.

Plate 7.10a. Weak hill slope

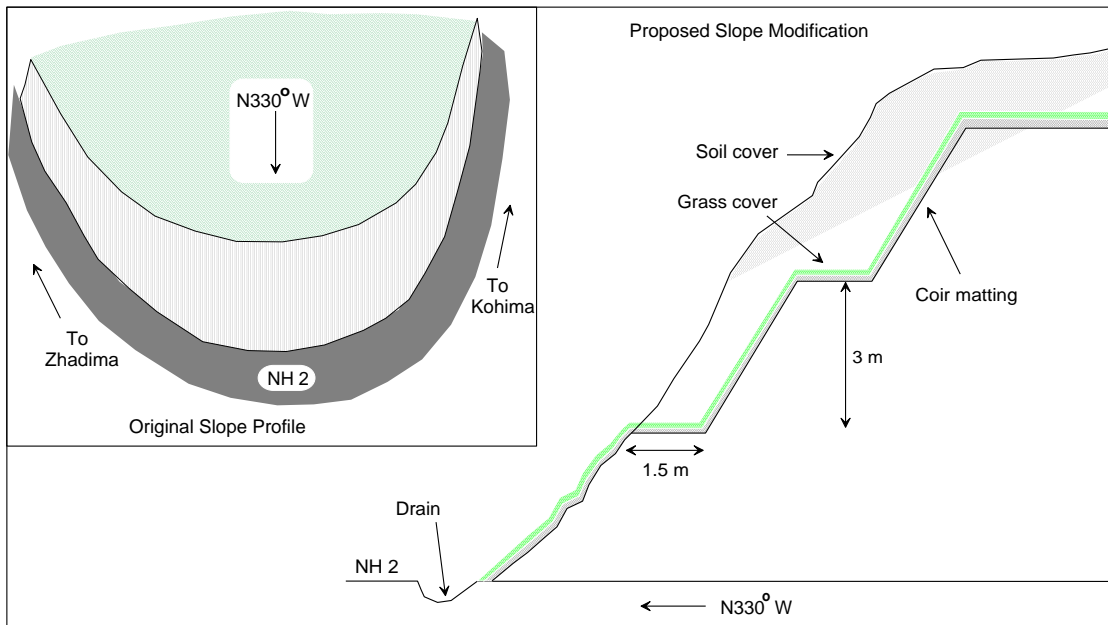
Fig. 7.10e. Proposed slope modification / mitigation measures

Base of bench	- 1.5 m
Height of bench	- 3 m
Length of bench	- 80 m
- ii. A carpet of grass planted on the exposed surface will serve to prevent excess seepage of water into the soil.

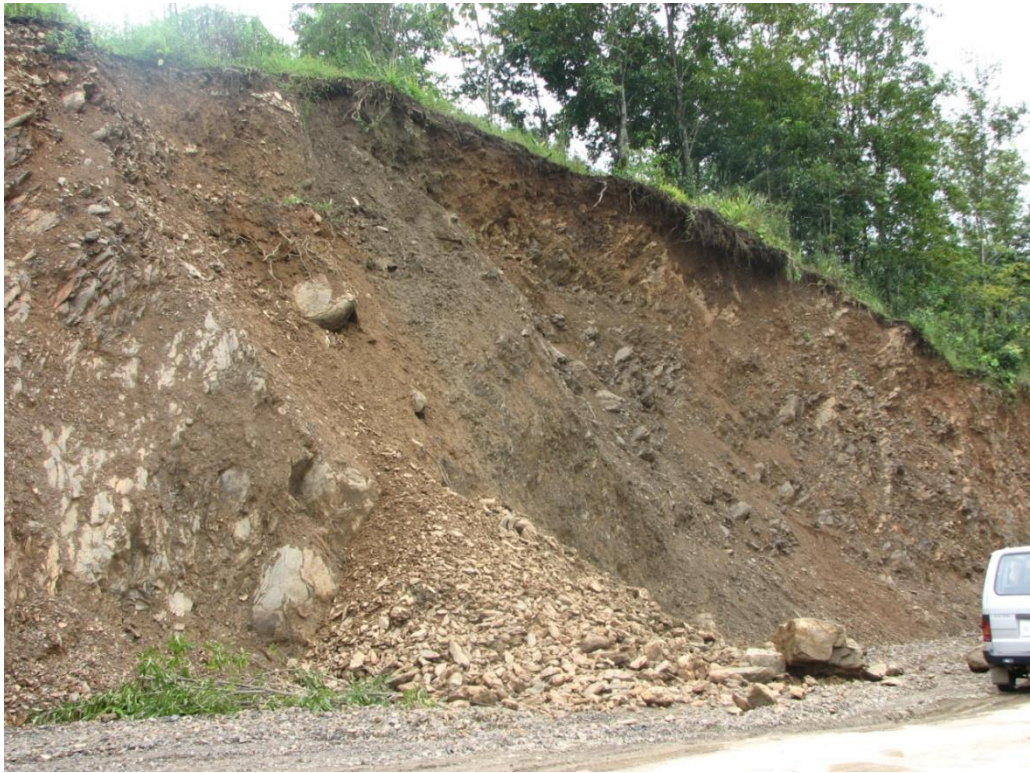
Plate 7.11a. Minor debris slide

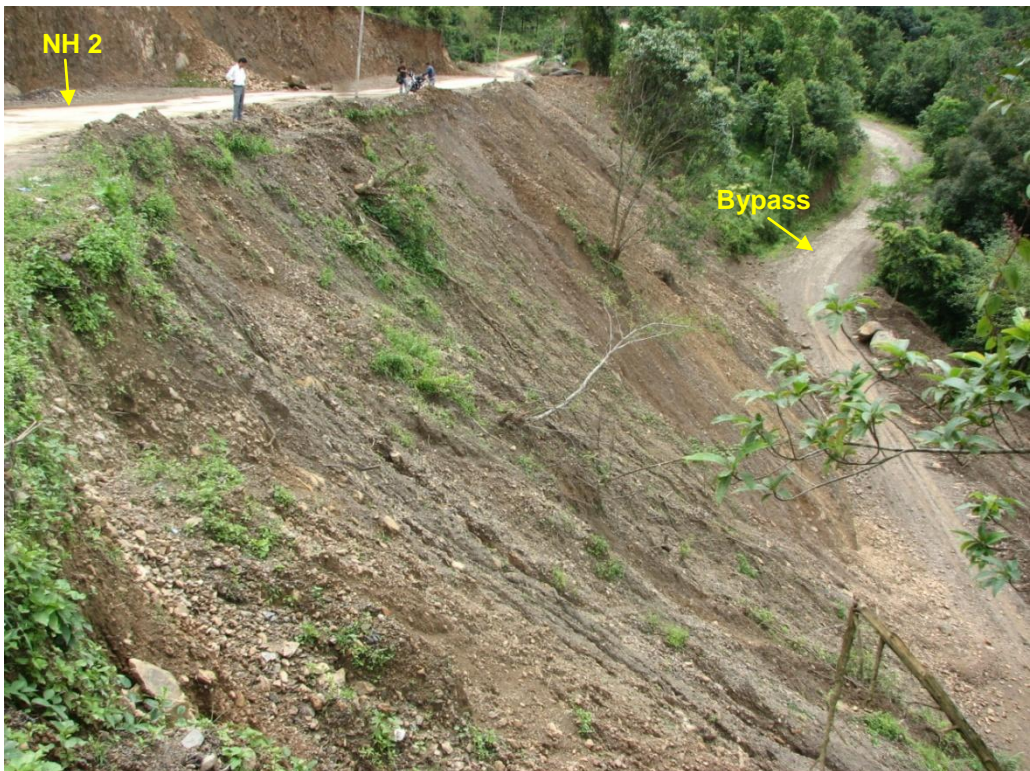
Road widening has destabilized the slope. The process left the slope without any support, as high as 8 m and at an angle of about 70°. The weak materials on these steep

Plate 7.11b. Unstable steep slope between NH 2 and Bypass

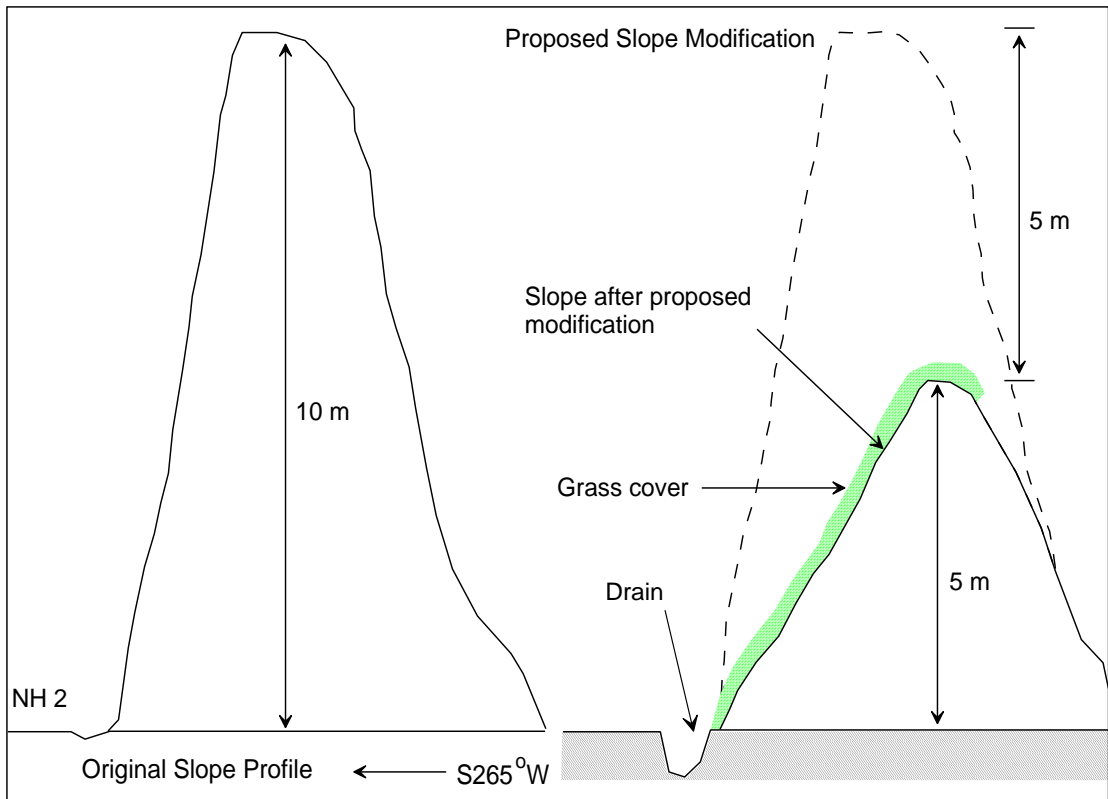
Fig. 7.11e. Proposed slope modification / mitigation measures

- i. The top of the ridge should be trimmed to about 5 m for a length of 100 m (Fig. 7.11e).
- ii. Electric poles on the ridge crest should be relocated.
- iii. A reduction of slope gradient is recommended.
- iv. A cover of grass along the modified slope will lend stability to the slope.
- v. Proper maintenance of the roadside drain is required.

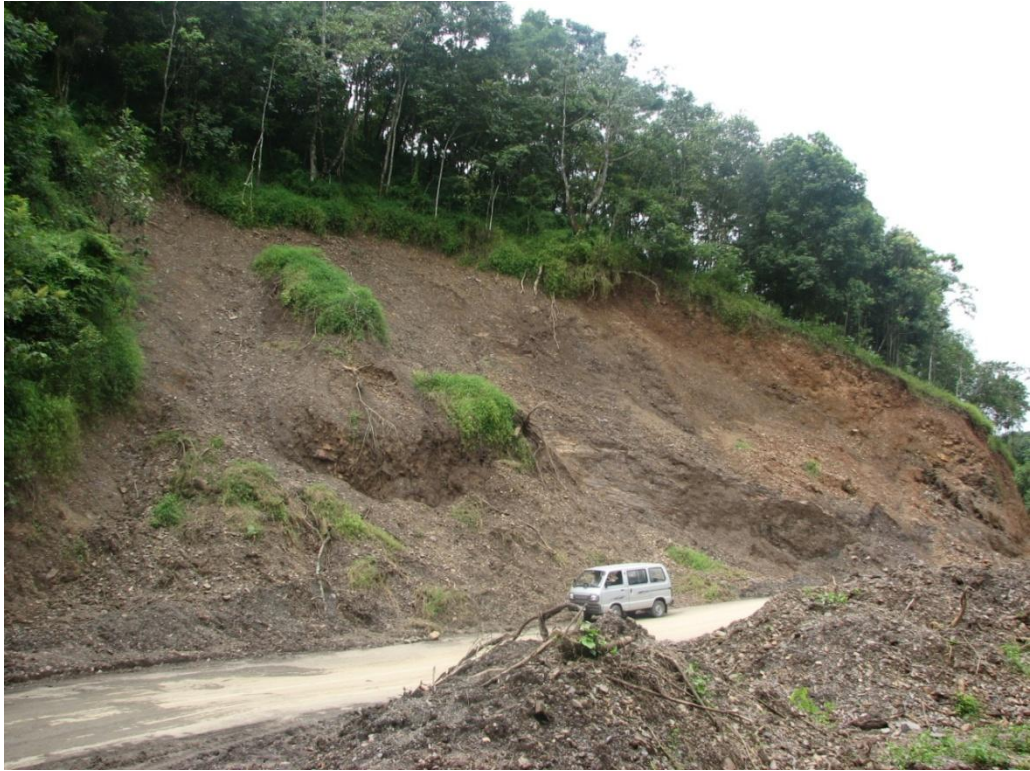
Plate 7.12a. Critical condition of slope

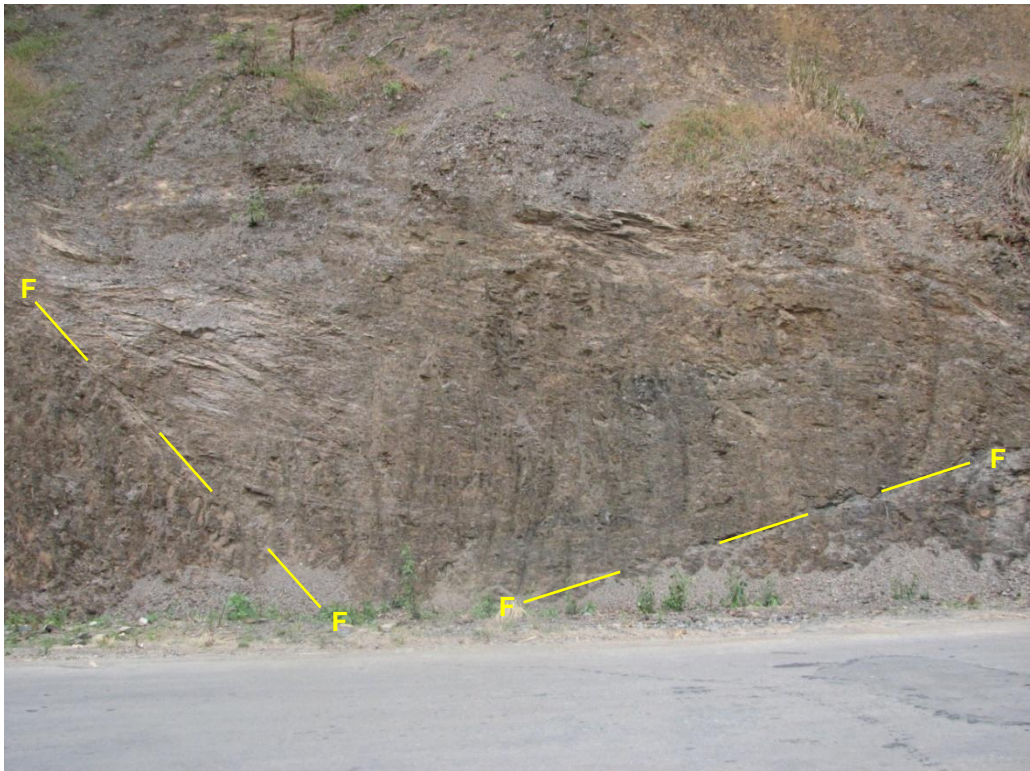
Plate 7.12b. Probability of wedge failure due to local faults

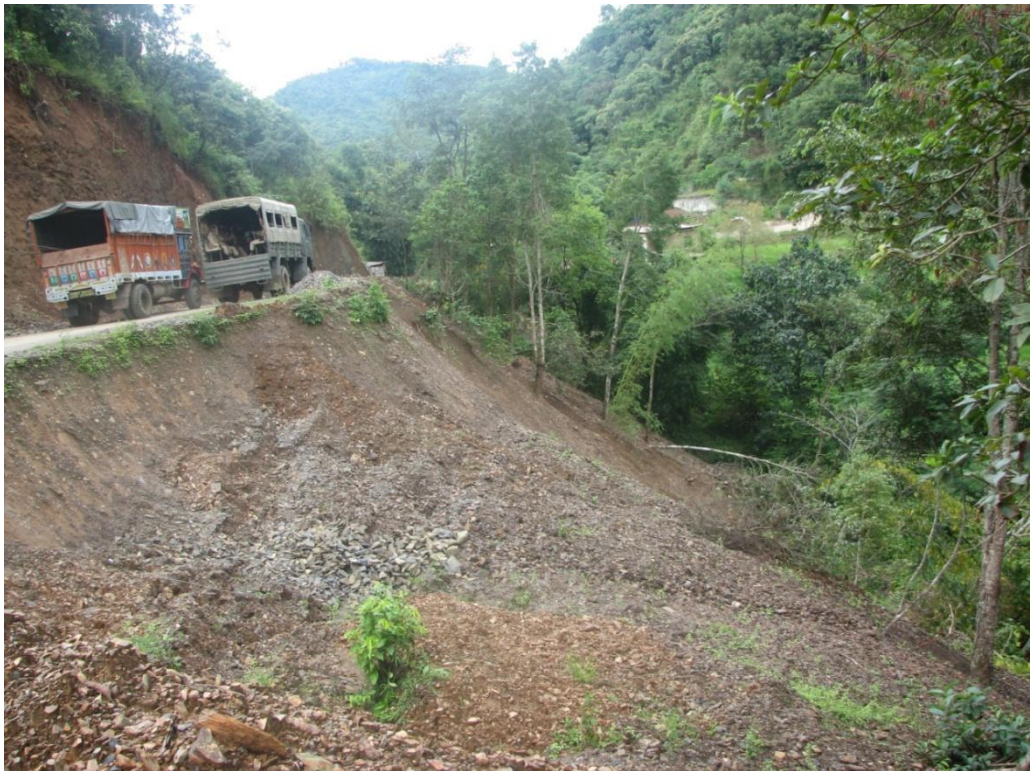
Plate 7.13b. Subsidence of portion of highway

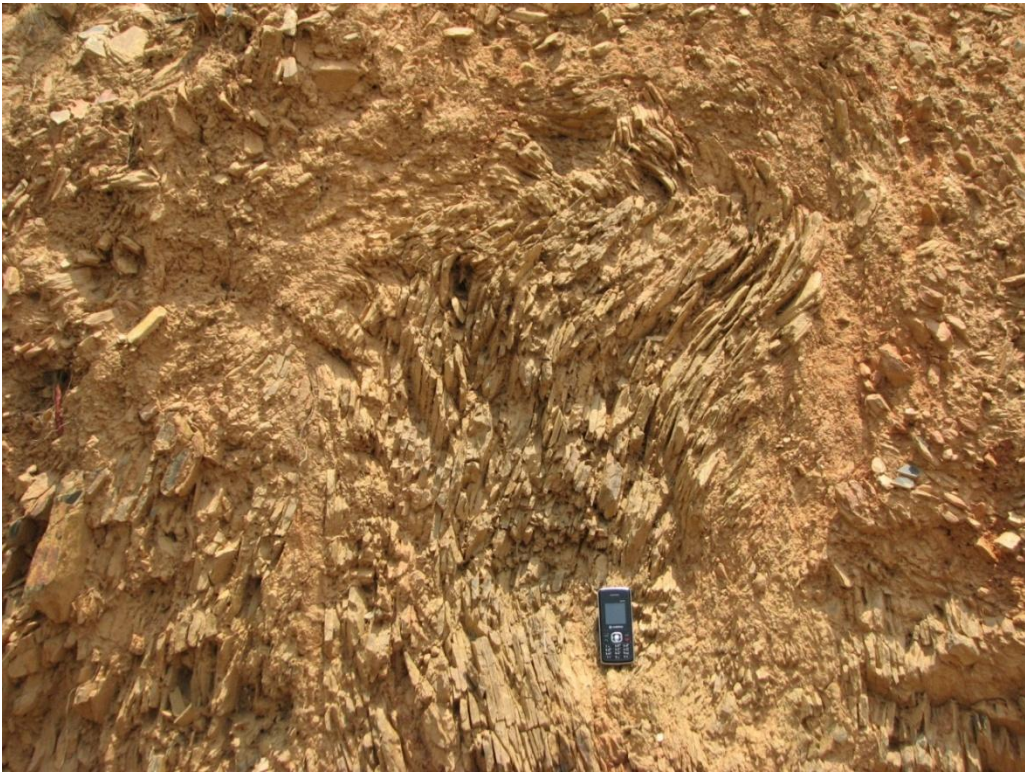
Plate

7.14a. Deformed shales

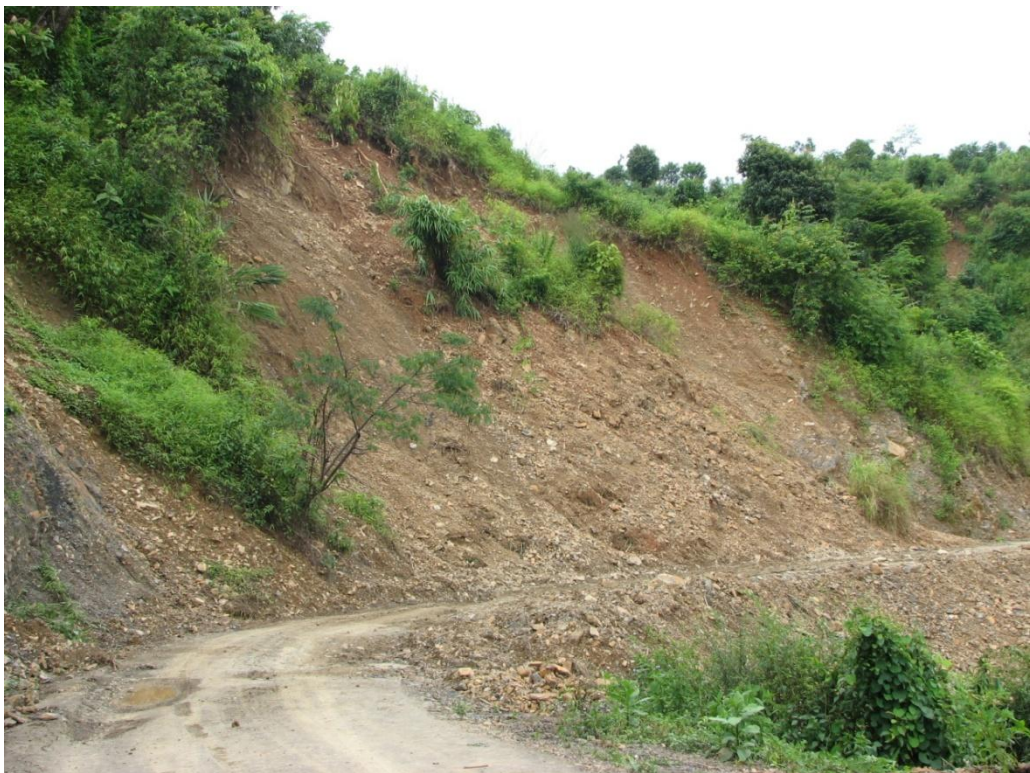
Plate 7.14b. Debris slide

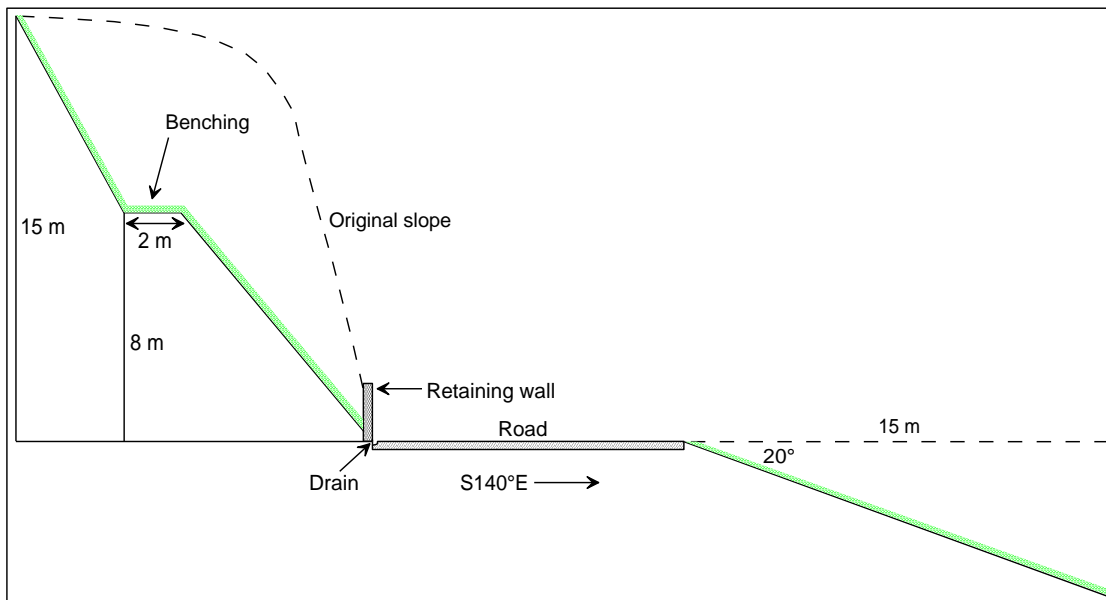
Fig. 7.13e. Proposed slope modification / mitigation measures

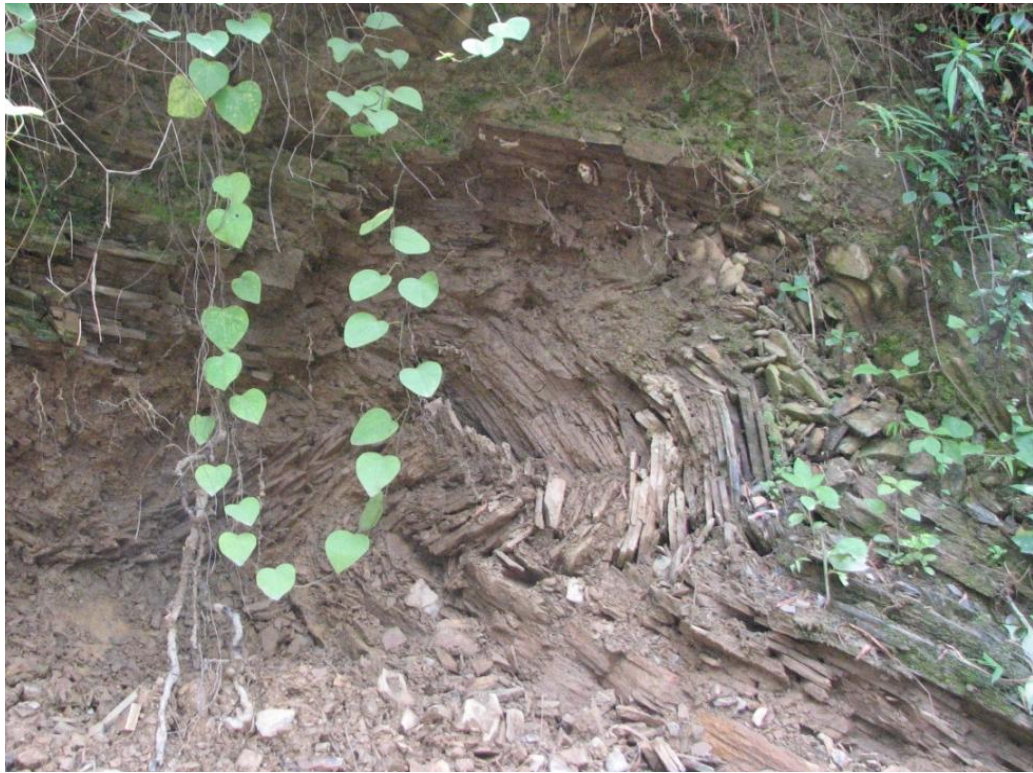
Plate 8.3. Crumpled and fractured shales

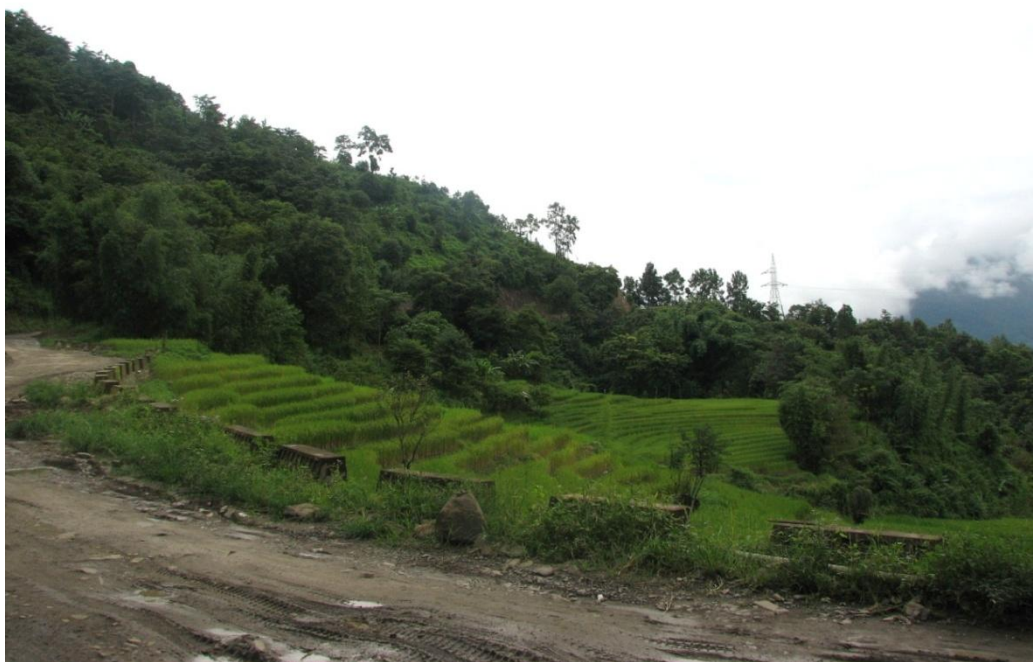
Plate 8.4. Damage of road due to terrace cultivation
