GEOLOGICAL INVESTIGATION OF LAND  
INSTABILITY IN KOHIMA TOWN,  
NAGALAND

IN PARTIAL FULFILMENT OF THE REQUIREMENT OF THE  
DEGREE OF DOCTOR OF PHILOSOPHY IN GEOLOGY OF  
NAGALAND UNIVERSITY

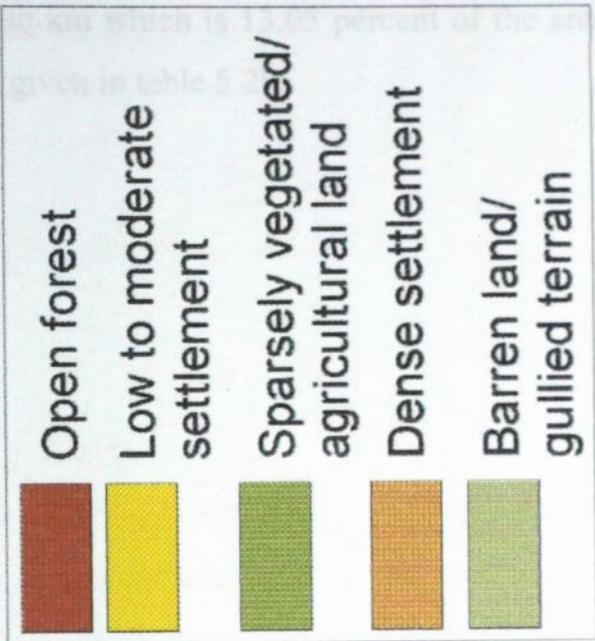
Fig. 5.6.2  
LAND USE / LAND COVER

This segment also includes all the 5 categories of land use and land cover (Fig. 5.6.2) including dense settlement, moderate to low settlement, open forests, sparsely vegetated and agricultural land, and gullied terrain and barren land (Table 5.1.2b). Dense settlement is noted in 3.4 sq km that accounts for 57.63 percent of the area of this segment. Moderate to low settlement is noted in 0.07 sq km which accounts for 1.18 percent of the area. Open forests occupy 0.22 sq km of the area of this segment and accounts for 3.73 percent of the area. Sparsely vegetated and agricultural land

occupy 1.44 sq km. This accounts for 24.41 percent of the area of segment 2. Burned land and gullied terrain occupy 0.77 sq km which is 13.05 percent of the area of this segment. Ratings for this segment are given in table 5.2b.

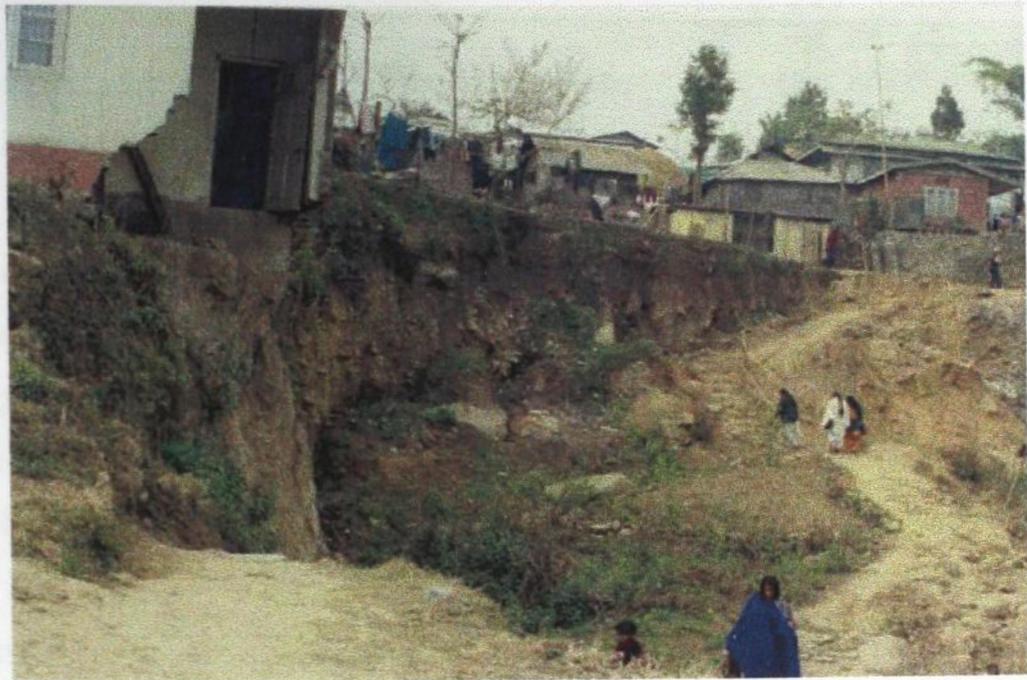
**Plate 7.1.1**

The Chiepfütsiepfe slide occurred in July 1993. It lies at 94°07'00" E longitude and 25°39'36" N latitude. It is part of Toposheet no. 83 K/2 of the Survey of India. The length of the slide is about 165 m and breadth about 130 m. This is a rotational slide that is spoon-shaped in appearance (Plates 7.1.1 & 7.1.2).

Chiepfütsiepfle slide

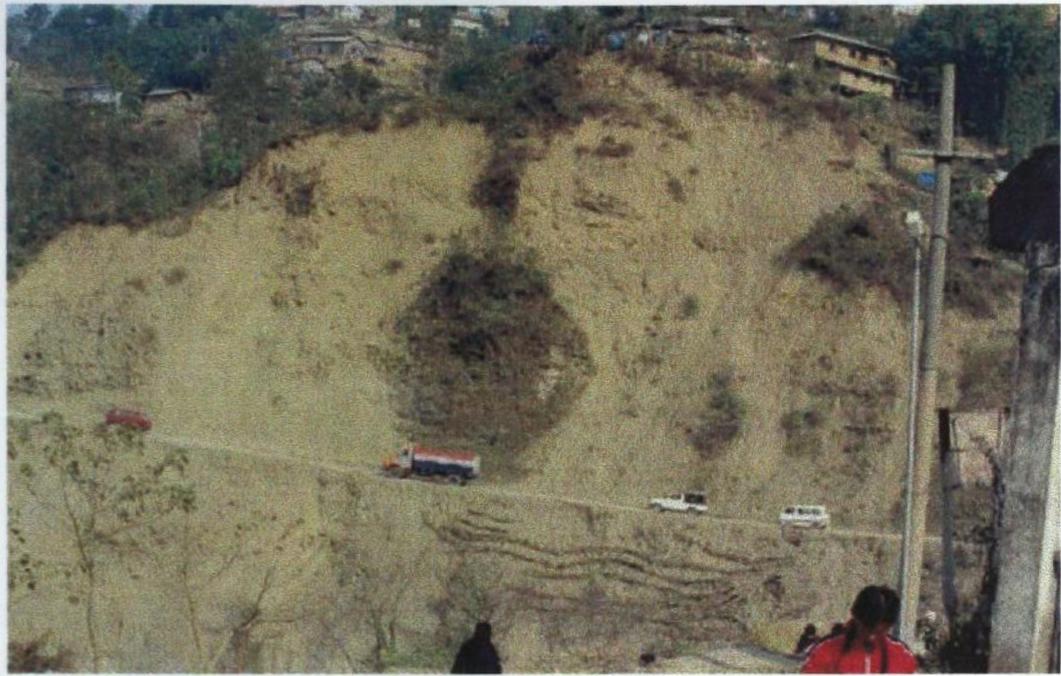
**Plate 7.4.1**

Paramedical Subsidence Zone  
(Before treatment)

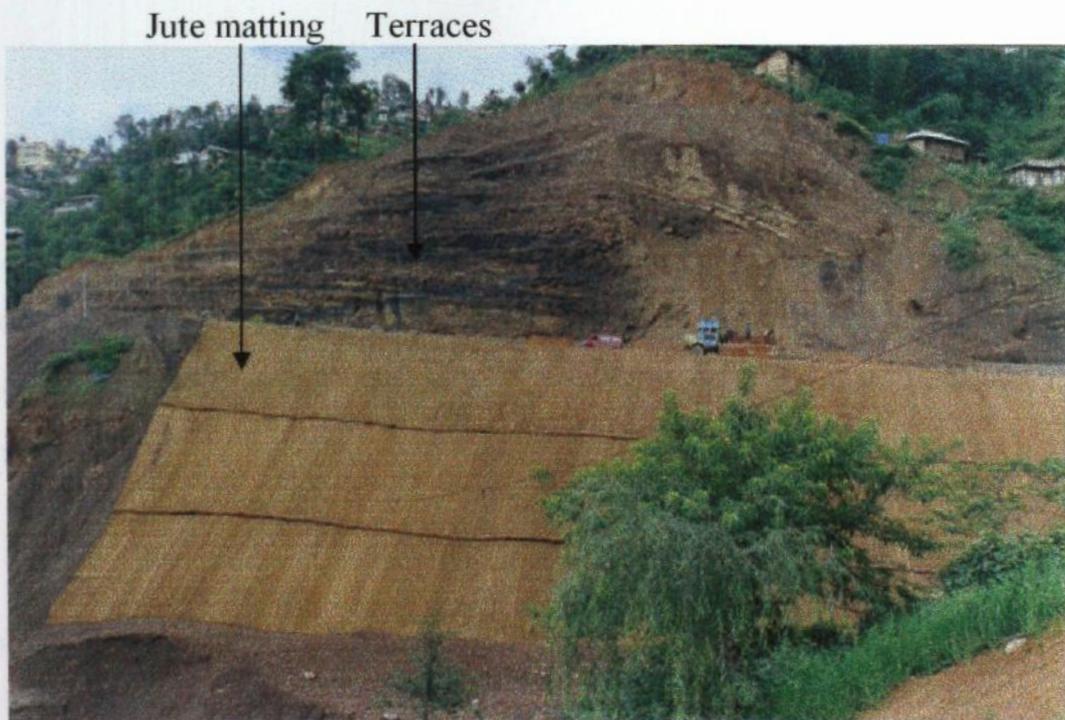
**Plate 7.4.2**

Paramedical Subsidence Zone  
(Benching and Coir matting)

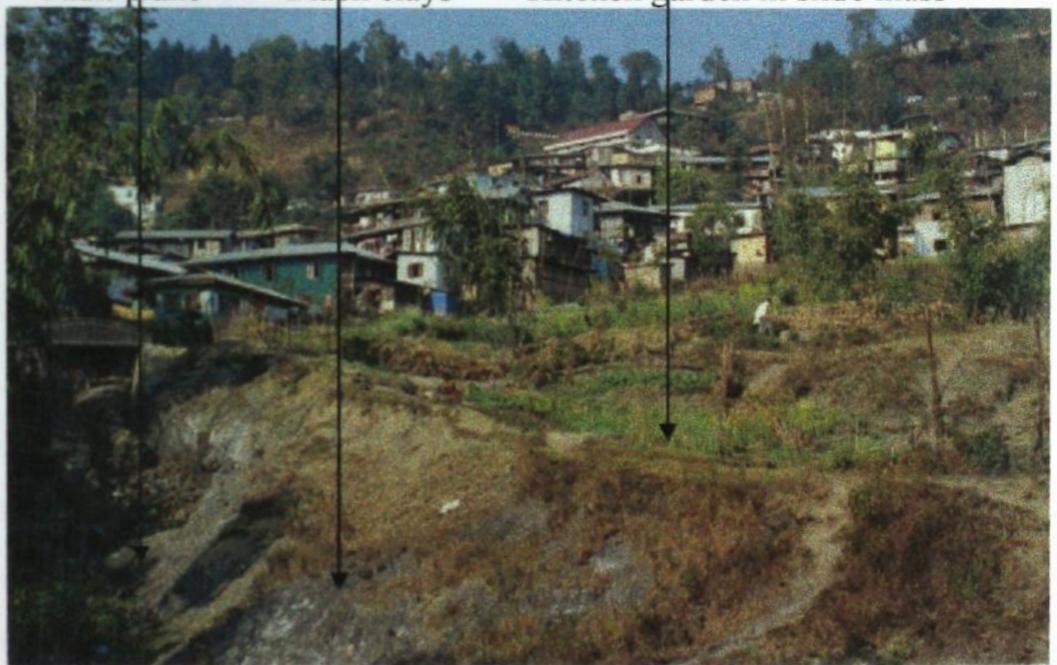
Plate 7.5

Midland Slide
