**SLOPE STABILITY INVESTIGATIONS BETWEEN
KOHIMA AND MAO
WITH SPECIAL REFERENCE TO NH-39**

MENIELE KHALO
Department of Geology

In partial fulfillment of the requirement of the Degree of
Doctor of Philosophy in Geology
of Nagaland University

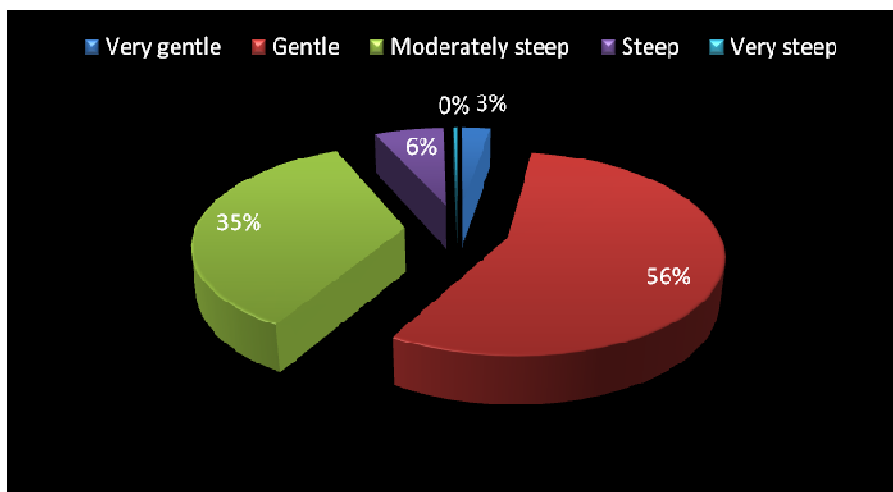
Fig. 5.1b Distribution of slopes

Category	Area		Landslide		Frequency
	km ²	%	No	%	No/km ²
Very gentle	0.48	2.65	-	-	-
Gentle	9.88	55.67	12	54.54	1.22
Moderately steep	6.49	34.97	9	40.91	1.45
Steep	1.18	6.37	1	4.55	0.88
Very steep	0.07	0.34	-	-	-

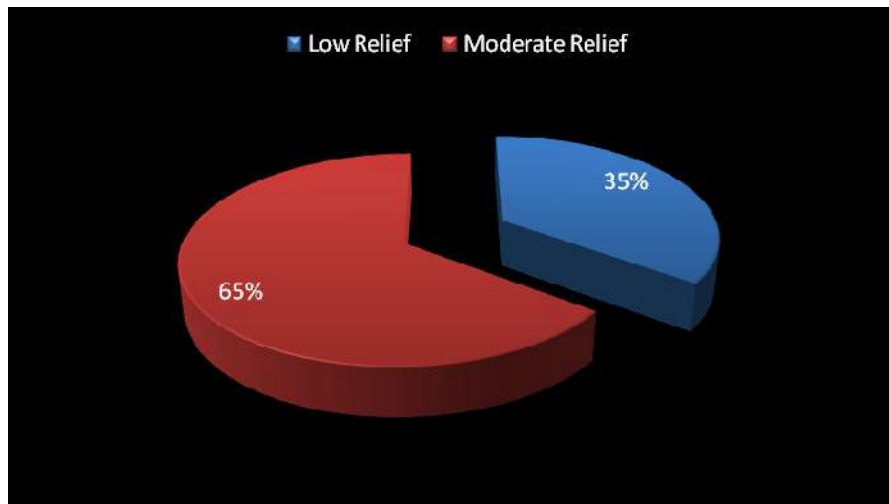
Fig. 5.2b Distribution of relative relief

Category	Area		Landslide		Frequency
	km ²	%	No	%	No/km ²
Low relief	6.36	35.14	7	31.82	1.1
Medium relief	11.74	64.86	15	68.18	1.28

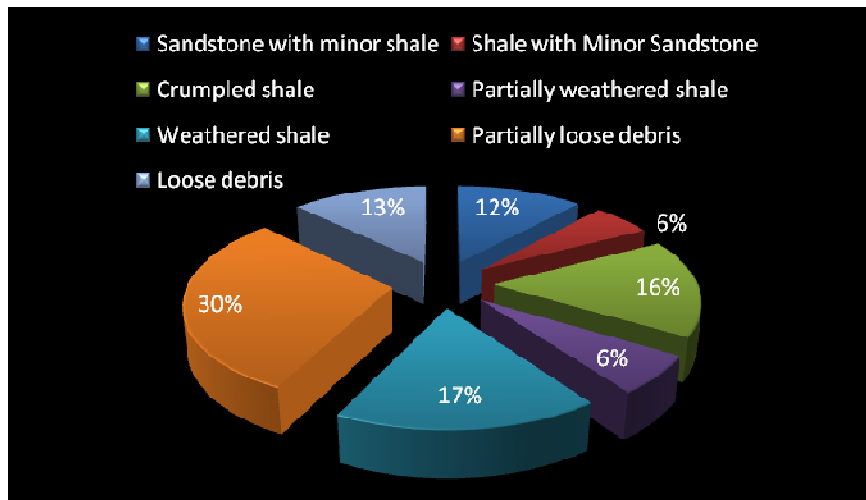
Fig. 5.3b Distribution of litho-units

Category	Area		Landslide		Frequency
	km ²	%	No	%	No/km ²
Sandstone with minor shale	2.13	11.77	-	-	-
Shale with minor sandstone	1.00	5.52	2	9.09	2.00
Crumpled shale	2.96	16.35	1	4.55	0.34
Partially weathered shale	1.15	6.35	1	4.55	0.87
Weathered shale	3.14	17.35	6	27.27	1.91
Partially loose debris	5.43	30.00	4	18.18	0.74
Loose debris	2.29	12.66	8	36.36	3.49

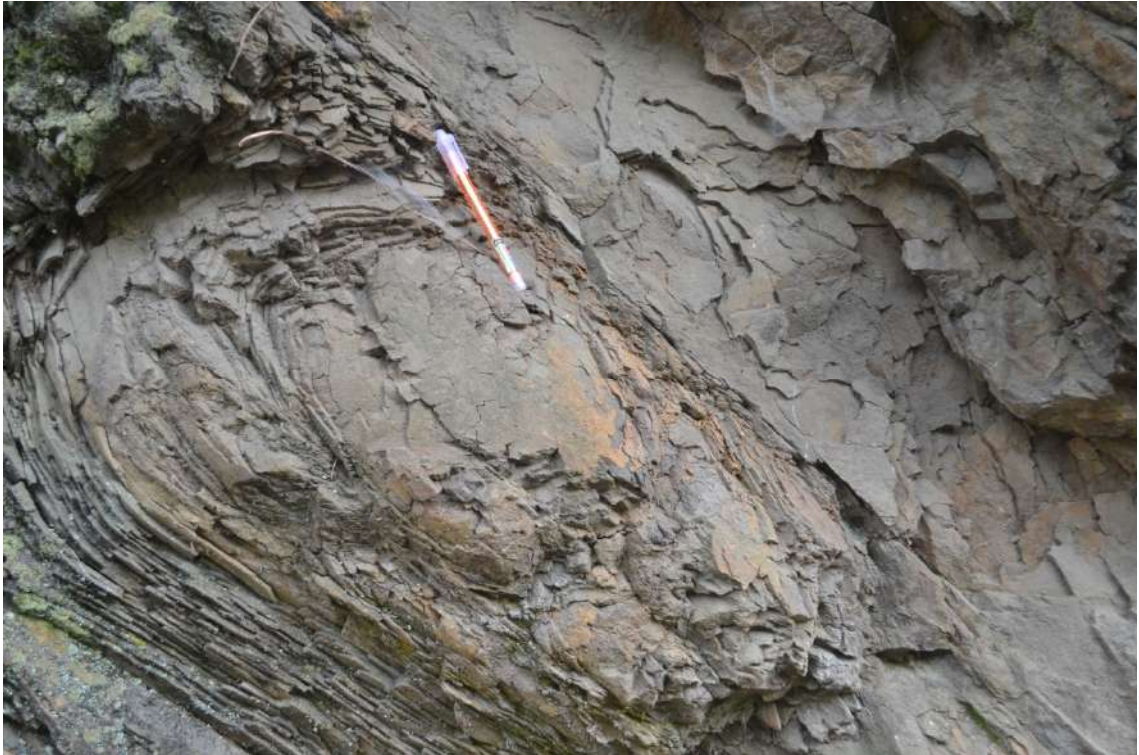
Plate 2.1 Spheroidal weathering

The Disang shales are distinguished for their organic content which gives the shales their characteristic dark gray to black colour. Box-work and spheroidal weathering (Plate 2.1) are common and the presence of pyrite in the Disang indicates that they were deposited under reducing conditions. Studies indicate that these rocks belong to a deep basinal set-up (Imchen, et al., 2014) and were deposited in a marine environment, probably at great depths where anoxic conditions prevailed. At a later date these sediments were uplifted. Ultimately weathering and erosion of the overlying rocks has exposed the present area. The Disang represents a flysch facies, they are found over more than half the surface area of Nagaland. As it goes higher up the stratigraphic column the volume of shales decreases and the presence of sandstone become more prominent. The Disang grade vertically and laterally into the

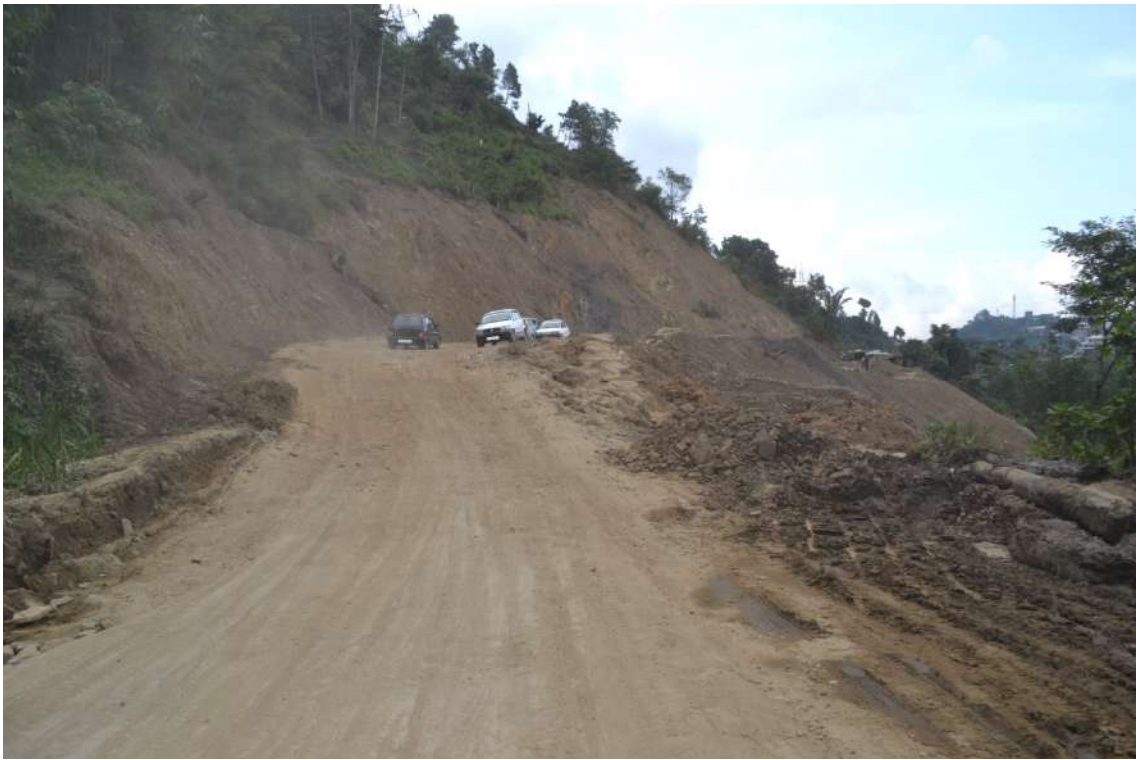
Plate 7.1.b Kisama Slide area

41475.29sq m. This slide has also affected about 150 m stretch of the NH 39 (Fig. 7.1). This is a multi-rotational slide that was subject to prolonged creep. Local creep still continues as is indicated by the condition and movement of man-made structures and trees (Plate 7.1.a). Continuous creep has been taking place since the landslide first gave way during the 1950's, and often after that. Recently it occurred again in 2013 in the early part of July and affected a length of about 600m in length and breadth of 120m (Plate 7.1.b)

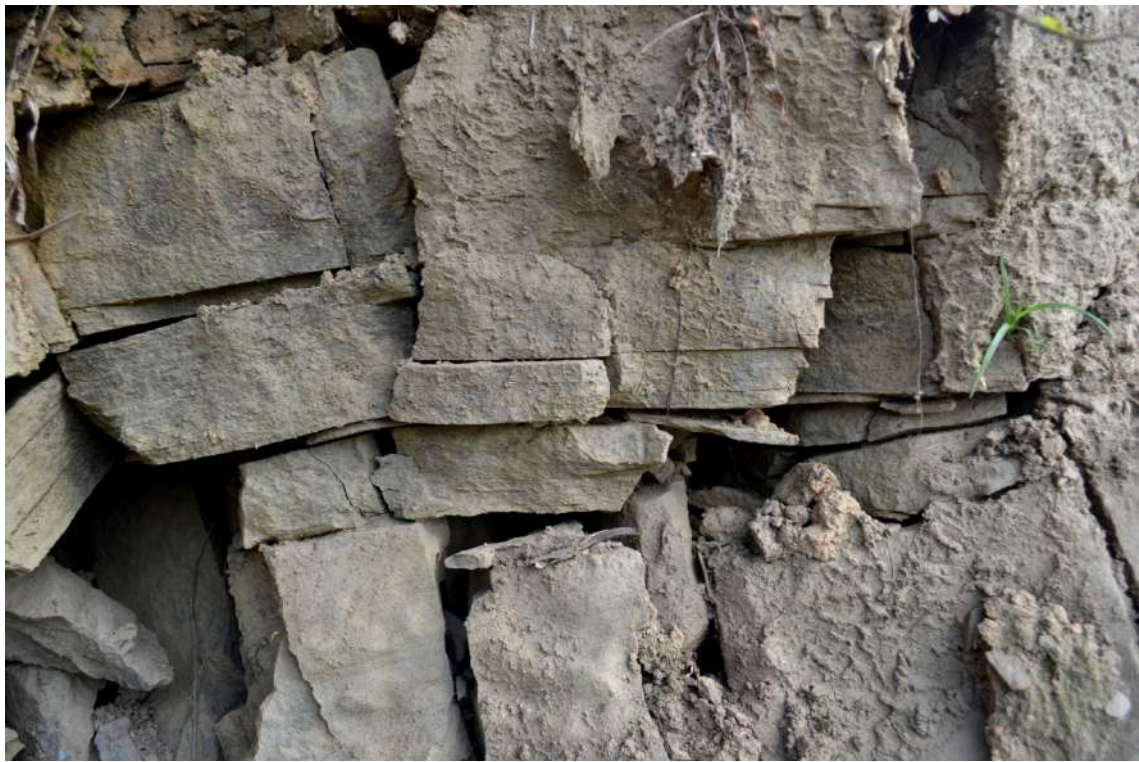
Plate 7.1.1.a Highly jointed and fractured sandstone

The area under investigation is a reactivated old slide and the Barail rocks have been severely affected by tectonism as seen by the highly jointed, fractured and sheared nature of the rocks (Plate 7.1.1a). A lineament trending NE-SW, traverses this area. Rock dips are variable due to local structural disturbances. Slickenside provides evidence (Plate 7.1.1.b) of the direction of movement. The general trend of the slope varies from 50°-60° in a NE direction. The rocks exhibit two prominent sets of joints. The first set of joints dipping at an angle of 35°, trends NW-SE. The second set dips

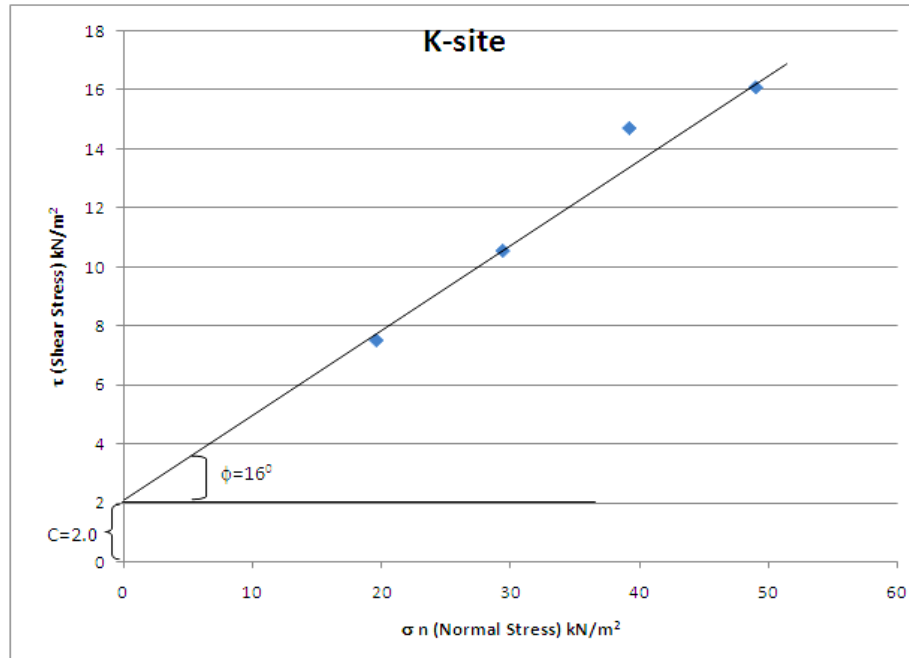
Fig. 7.1g Plots of normal and shear stresses for Kisama landslide soils

The results were plotted in a graph with Normal Stress (σ_n) as abscissa and Shear Stress (τ) as ordinate. A graph is drawn to obtain the Coulomb failure equation, $\tau=c+\sigma_n \tan\phi$, and shown in Fig. 7.1g. From the figure it is found that the value of C of the soil is about 2.0kN/m², and $\phi = 16^\circ$.

The cohesive strength (C) and internal friction angle are low, which means that these clayey soils may have some percentage of silt and fine sand. The values of cohesion and internal friction are 2.0 kN/m² and 16° respectively. Hence, slopes cut greater than the internal friction angle will, virtually be, unstable. Hence, landslides will be common if slope cuts are greater than 16° in these areas.

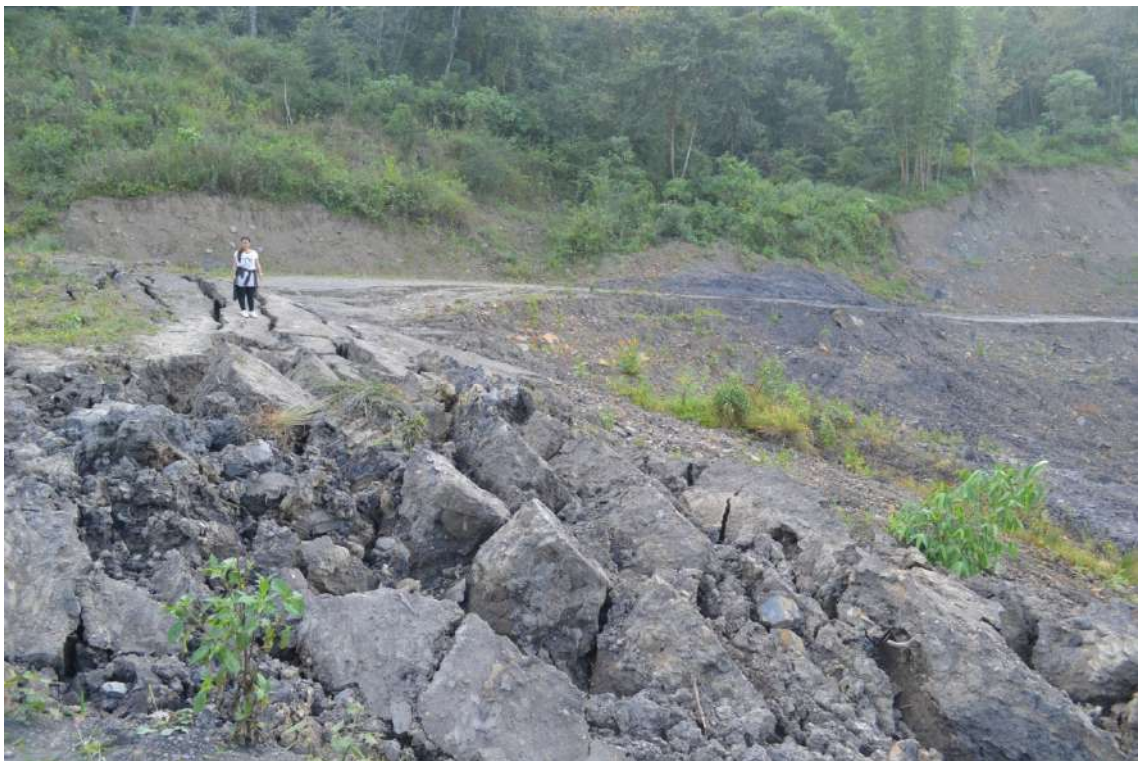
Plate 7.2.2.a Road section affected by landslide

These factors together had caused a large section of the road to be washed away (Plate 7.2.2.a). This was a warning sign that went unheeded and ultimately led to the massive devastation where all the terrace fields of the village were destroyed. The process also leads to overflow of water, debris, and mud. Loss of frictional resistance due to excess moisture had lead to reduction of shearing strength and resulted in a devastating landslide. The area remains damp and marshy throughout the year due to a very shallow water table. On the lower reaches of the slope a road leads to the village located immediately below the highway. The slope had been cut and modified for construction of road but it needs careful monitoring as it is severely affected. It is no longer motorable as part of the road is gone. The fault traversing the area, unfavourable fresh-cut slopes, the terrace cultivation and the intense water together caused instability in the area.

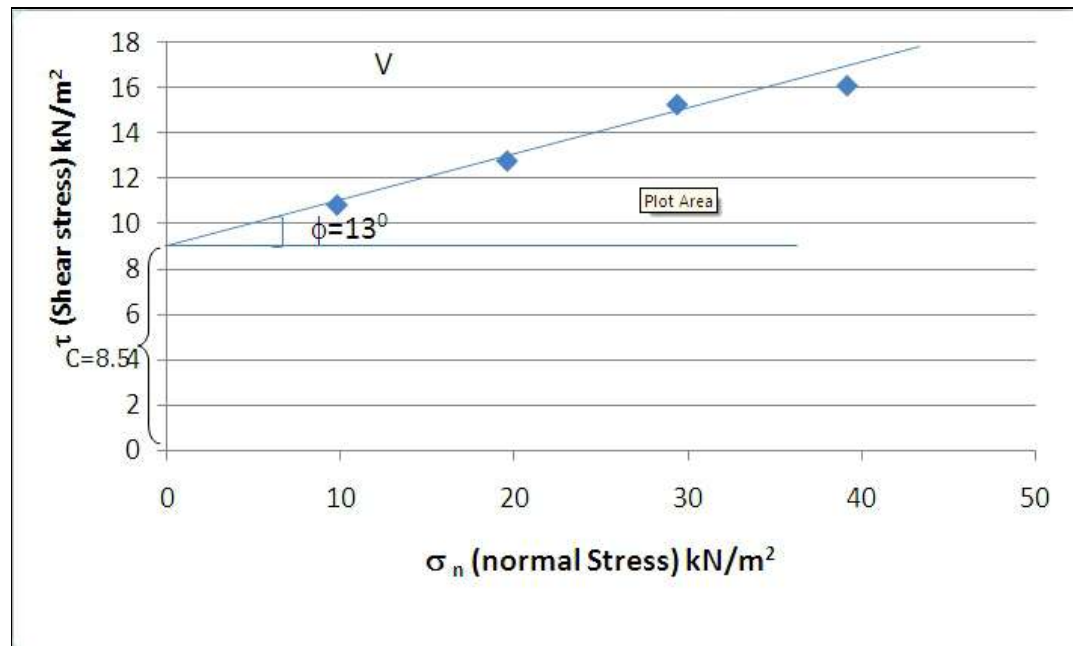
Fig. 7.2g Plot of normal stress and shear stress for Viswema landslide soils

The results of these tests are plotted in a graph where Normal Stress (σ_n) is plotted as the abscissa and the Shear Stress (τ) as the ordinate. A best fit line is drawn to give the Coulomb's failure equation, $\tau=c+\sigma_n \tan\phi$, and shown in Fig. 7.2g.
