**GEOLOGICAL INVESTIGATION OF LAND
INSTABILITY BETWEEN KOHIMA AND ZHADIMA**

SUPONGTEMJEN

**DEPARTMENT OF GEOLOGY
NAGALAND UNIVERSITY**

October 2012

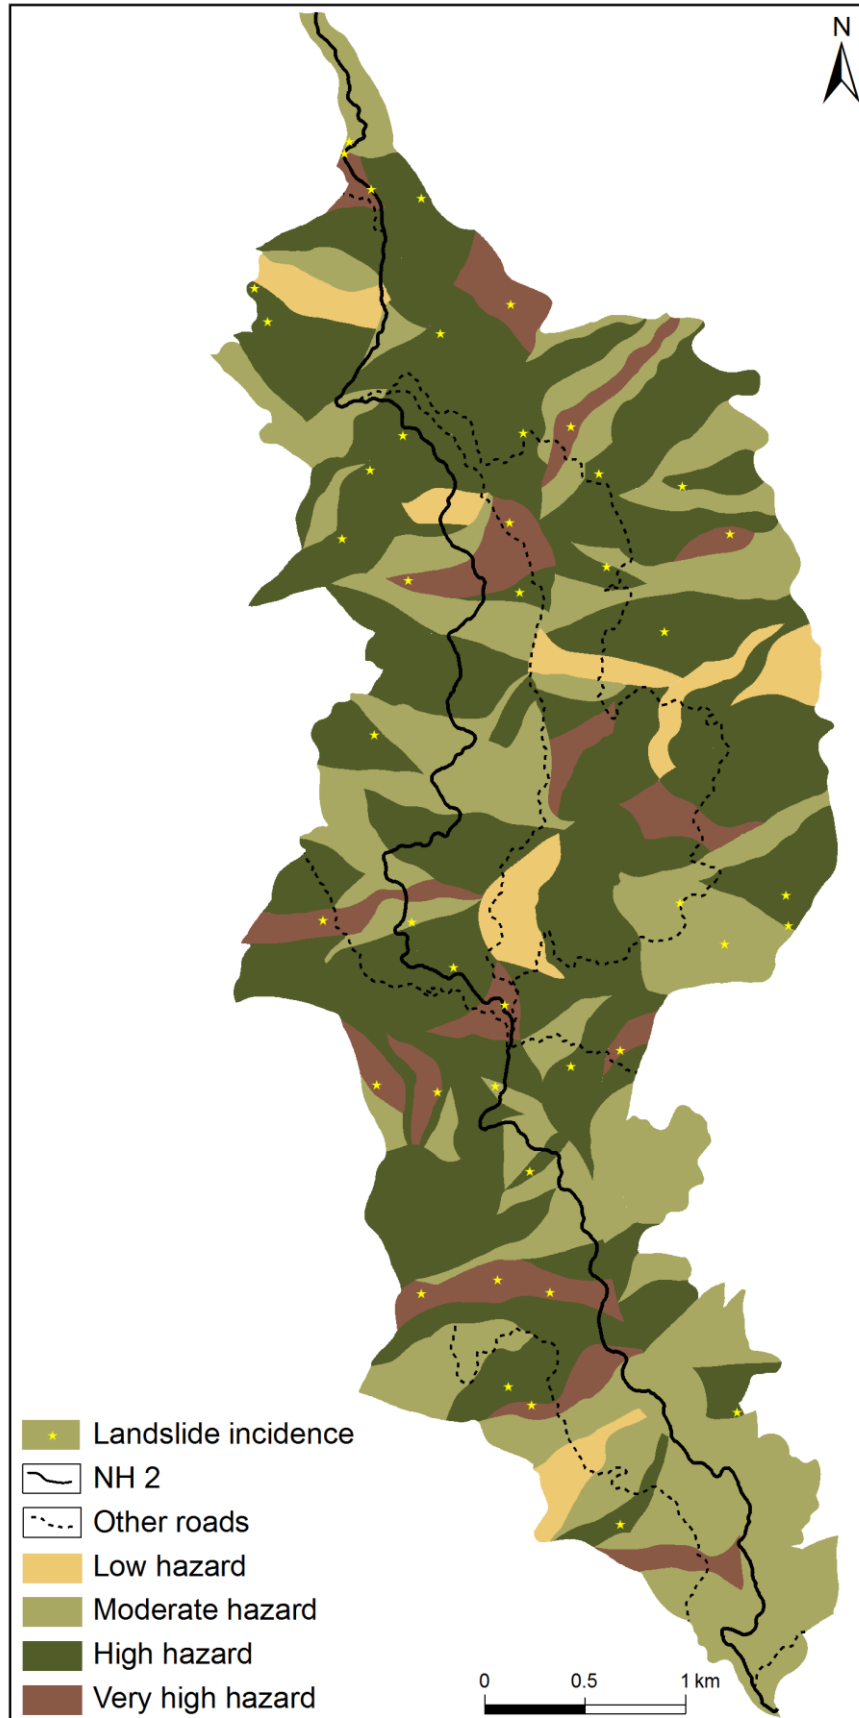
Fig. 6.1a. Landslide hazard zonation map

The LHZ map delineates the area of investigation into four classes comprising low, moderate, high, and very high hazard zones (Fig. 6.1a). Low hazard zones occupy an area of 0.73 sq km. This represents 5.23% of the total area of study. Moderate hazard areas cover 4.93 sq km which is 35.51%. High hazard areas occupy 49.88% covering 6.93 sq km, while very high hazard areas occupy 1.30 sq km, which is 9.38% of the total area. Ratings for the various hazard zones are generated (Table 5.1). Table 6.1 shows the frequency of landslides on the various hazard classes. The pie charts show the distribution of hazard zones and the frequency of landslide incidences on hazard zones (Figs. 6.1b).

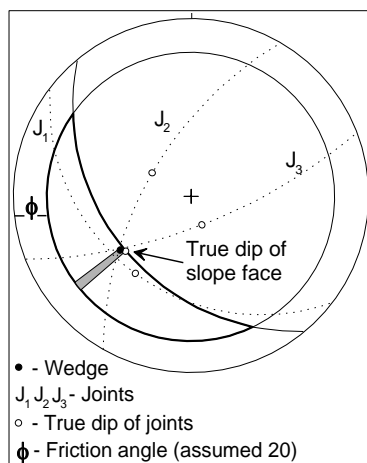
Fig. 7.1c. Stereogram

5. Groundwater condition	Dry	10
RMR	$(1+2+3+4+5)$	44
6. $F_1 = (1 - \sin \alpha_j - \alpha_s I)^2$	10°	0.70
7. $F_2 = \tan^2 \beta_j$ or $F_2 = 1$ for toppling	40°	0.85
8. $F_3 = I\beta_j - \beta_s I$ for plane failure = $I\beta_j + \beta_s I$ for toppling where β_s = dip/angle of slope	-10°	-50
9. F_4 = Adjustment factor	Pre-splitting	10
SMR = $RMR + (F_1 \times F_2 \times F_3) + F_4$	$44 + \{0.70 \times 0.85 \times (-50)\} + 10$	24.25
10. Class	IV	
11. Description	Unstable; planar or large wedges

Kinematic analyses have been performed for determination of mode of failure in jointed rock masses. About 165 joint attitudes taken in the field are plotted in pole (Fig. 7.1a) and contour diagrams (Fig. 7.1b). From the contour diagrams, three dominant joint sets are identified (J_1 : 45°→217°, J_2 : 69°→300°, J_3 : 76°→159°), which are plotted against slope (50°→230°) in a stereographic projection (Fig. 7.1c).

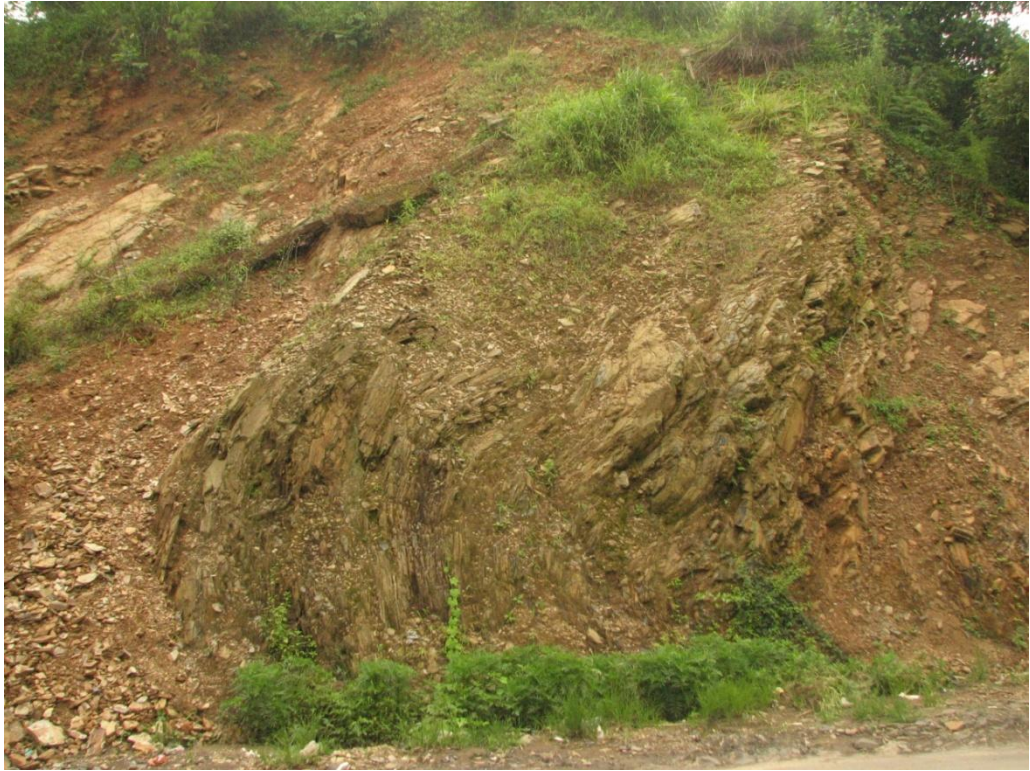
Plate 7.1a. Folded and crumpled Disang shale

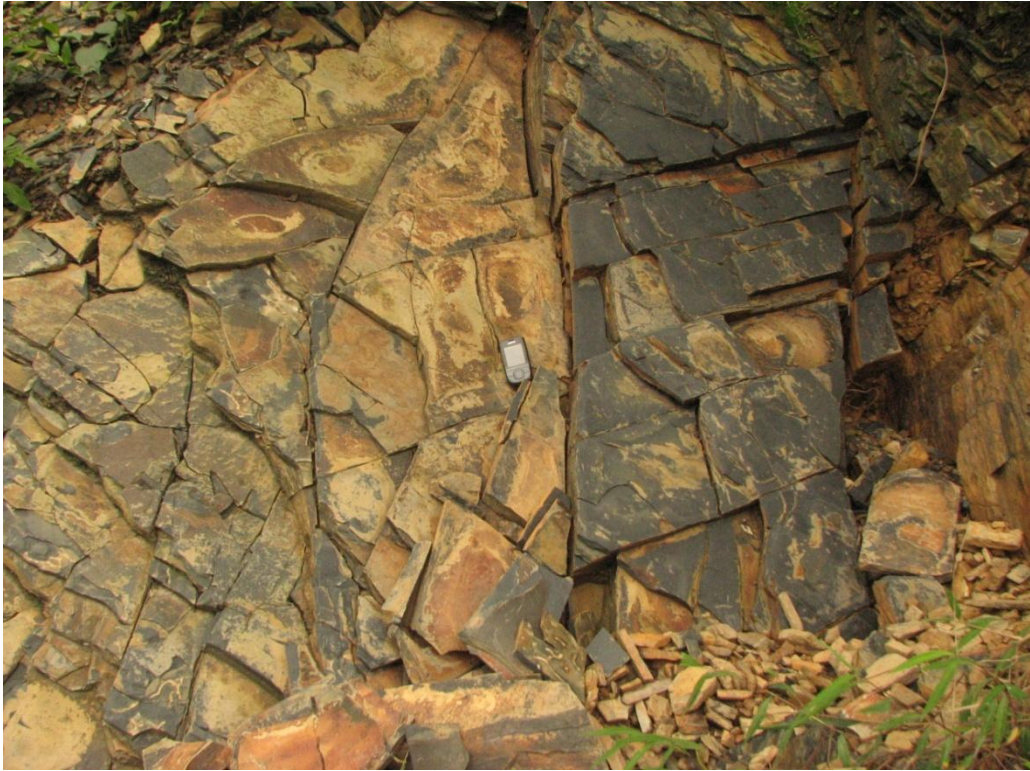
Disang rocks in the area, comprising abundant shale, make up the sediments of this area. The bedrocks are weathered shale, brown to dark gray, and often interbedded with minor siltstone. The brown color of the shale is due to iron oxidation. These rocks are highly crumpled and exhibit three prominent sets of joints, viz. 74°→210°, 77°→246°, and 72°→283° (Plate 7.2a) and one set of bedding joints. The clayey soils are mixed with rock fragments. The bedrocks are overlain by thick piles of regolith (about 5 m). The trend of the rocks is NE-SW to N-S with varying degrees of dips.

Plate 7.2a. Highly jointed Disang shale

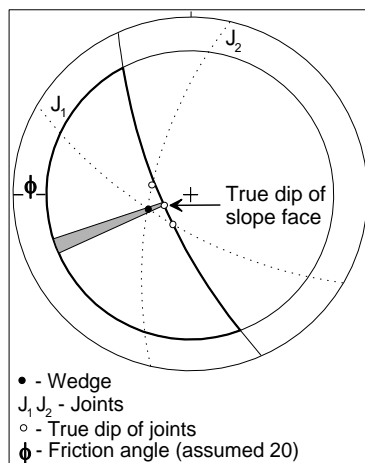
Fig. 7.2c. Stereogram

The stereogram shows that both the true dips of the joint planes J_1 and J_2 lie outside the shaded region. In such cases double plane failure takes place (Yoon et al., 2002). It is therefore concluded that double plane wedge failure may occur along this portion of the highway. A rosette is constructed from the joint data (Fig. 7.2d). The orientation of joints indicates the prominence of antithetic shear stresses.

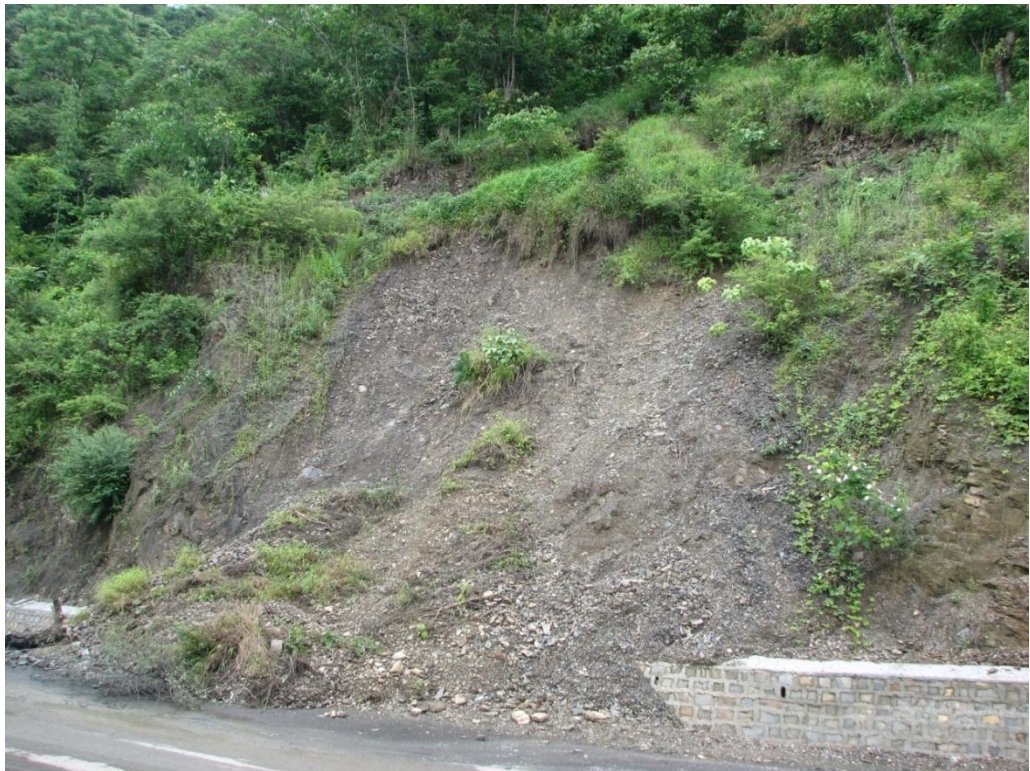
Plate 7.3b. Choked drain

height from 6 to 15 m and has been left at an angle of about 80°. The jointed rocks allow water seepage into the subsurface during the monsoon. Debris and plants had completely blocked the drain and part of the highway in August 2011 (Plate 7.3b).

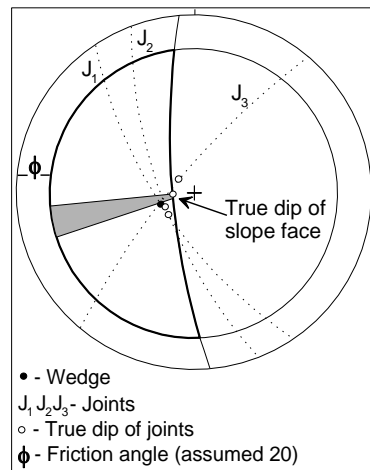
Fig. 7.3c. Stereogram

The true dips of the joint planes J_1 and J_3 lies outside the shaded region between the true dip of the slope and the line of intersection of the two joint planes (J_2 and J_3). J_2 plotted against slope shows probability of planar failure. Analyses of joint intersections (J_2 and J_3) indicate that wedges form small blocks in the rocks. It is concluded that both planar and wedge failure may occur along this portion of the highway. A rosette constructed from joint data (Fig. 7.3d) indicates complex structural deformations which have sheared the rocks.

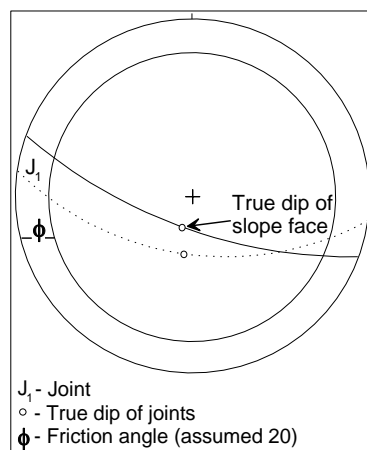
Fig. 7.4c. Stereogram

215 joint attitudes are taken for kinematic analyses. From the joint analyses data pole density (Fig. 7.4a) and contour diagrams (Fig. 7.4b) are constructed and from which the dominant joint ($J_1: 63^\circ \rightarrow 188^\circ$) is identified. These are plotted against slope attitude ($75^\circ \rightarrow 200^\circ$) in a stereographic projection (Fig. 7.4c).

The true dip of the joint plane J_1 lies at an angle of $\pm 12^\circ$ with respect to the true dip of the slope face. According to Hoek and Bray (1981) such relationship indicates planar mode of failure. It is therefore concluded that planar or soil like failure is likely to occur here. A rosette constructed from joint data (Fig. 7.4d) indicates synthetic shearing of rocks.

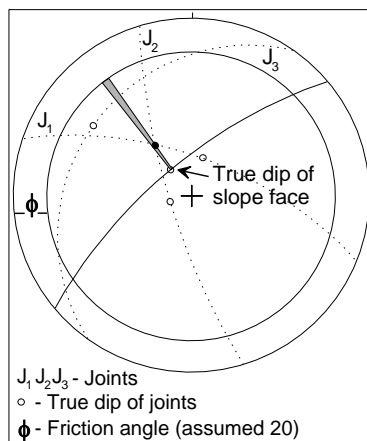
Fig. 7.5c. Stereogram

For the determination of the probable mode of failure, about 200 joint attitudes are taken for kinematic analyses. Joints are analyzed to construct pole density (Fig. 7.5a) and contour diagrams (Fig. 7.5b), from which three dominant joint sets are identified. These are plotted against slope attitude in a stereographic projection (Fig. 7.5c).

The true dips of the joint planes J_1 and J_2 lie outside the shaded region as seen in the diagram. This indicates double plane wedge failure. Analyses of joint intersections (J_1 and J_2) indicate that wedges form small blocks in the rocks. J_3 plotted against slope shows the probability of planar failure. It is therefore concluded that both planar and wedge failure are likely to occur along this section of the road. The rosette of this location shows that the lineaments are in conformity with that of the general trend of the region that is affected by F_1 folds. The rocks are also faulted along this plane (Fig. 7.5d). Antithetic and synthetic shearing stresses have also played a role in rock deformation.

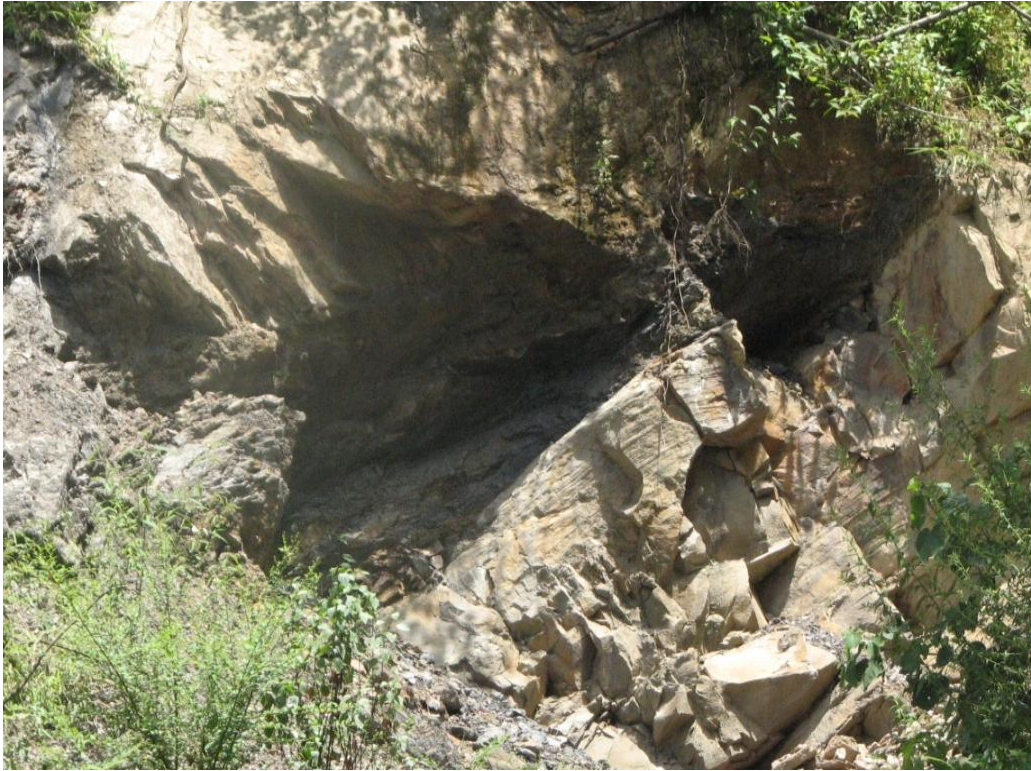
Plate 7.6a. Local deformation of rocks

The area is predominantly made up of weathered shale intercalated with fine grained, brownish sandstones. The rocks are highly deformed due to local faulting (Plate 7.6a). Slickensides provide evidence of the direction of movement. These rocks exhibit three prominent sets of joints. The first set trends NE-SW and dips 75° SW. The second set trends WNW-ESE with dips of 54° towards SSW. The third set trends NNW-SSE with steep dips of 69° towards SW.

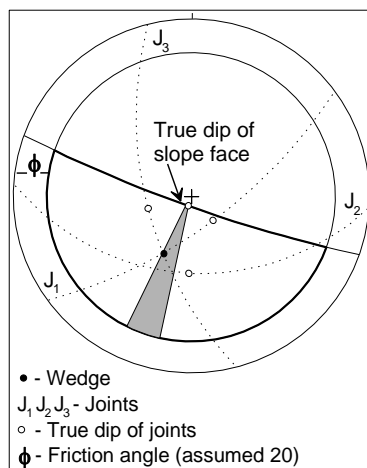
Fig. 7.6c. Stereogram

The true dips of the joint planes J_1 and J_3 lie outside the shaded region indicating double plane wedge failure. J_2 plotted against slope shows the probability of planar failure. Therefore both planar and wedge failure are likely to occur along this portion of the highway. Analyses of joint intersections (J_1 and J_3) indicate that wedges form small blocks in the rocks. The rosette of this location shows the dominant role of synthetic shears (Fig. 7.6d).

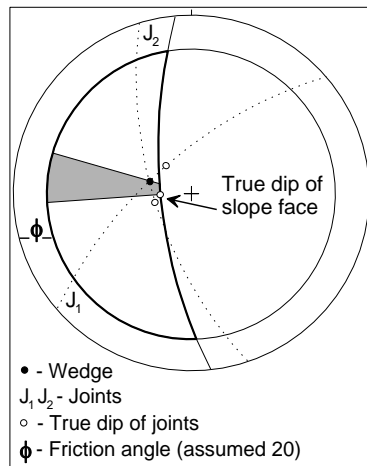
Fig. 7.7c. Stereogram

Kinematic analyses have been performed for determination of possible failure mode. 205 joint attitudes taken in the field are analysed to construct pole density (Fig. 7.7a) and contour diagrams (Fig. 7.7b) and from which three dominant joint sets are identified. These are plotted against slope attitude in a stereographic projection (Fig. 7.7c).

True dips of joint planes J_1 and J_2 lie outside the shaded region which indicates that double plane wedge failure is likely in this area. Analyses of joint intersections (J_1 and J_2) indicate that small blocks of wedges are common in the rocks. The rosette (Fig. 7.7d) shows that the lineaments are parallel to the F_1 folds and thrusts of the region, so squeezing of rocks in the compression direction would have crumpled them to a great extent causing weakness of the slope forming material.

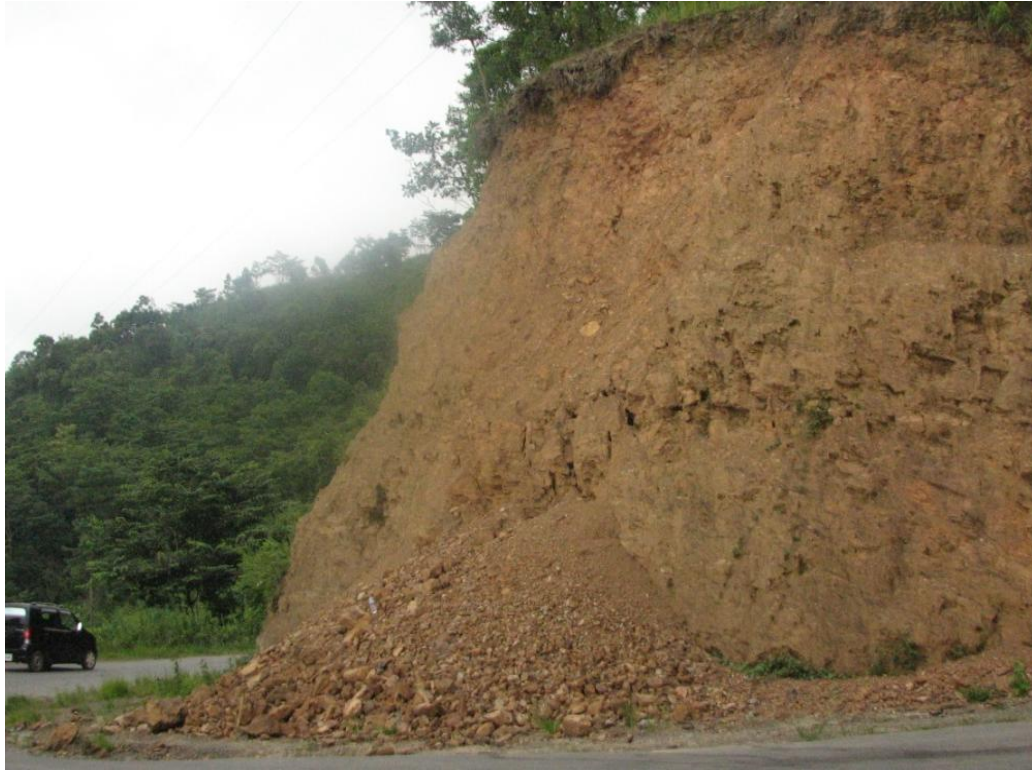
Plate 7.8a. Brown Disang shale

This area is predominantly made up of brown Disang shale (Plate 7.8a) intercalated with minor siltstone. The rocks are jointed and crumpled, portions being highly weathered. The rocks dip at angles of 45° towards SW. These jointed shales are also affected by prominent fissures of about 3-6 cm (Plate 7.8b). The rock exhibits three prominent sets of joints. The first set trends NW-SE and dips 60° SW. The second set trends N-S, dipping towards the west at angles of 69°, while the third set dips 75° towards SSW.

Excavations for widening of the highway without consideration for stability left the slopes as high as 12 m at angles of 75° without any support. Weathered shale and loose debris on unfavorable slope are prone to sliding. It is for such reasons that small debris slides have been triggered along this highway. Debris partially blocked the roadside drain.

- i. Slope gradient should be reduced.
- ii. A retaining wall of 2 m height will protect slope material from sliding down.
- iii. Proper roadside drain and periodic maintenance is recommended.

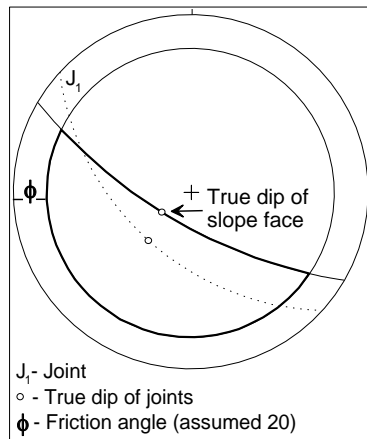
Fig. 7.8c. Stereogram

The true dip of the joint plane J_1 lies with at angle of $\pm 12^\circ$ with respect to that of the slope face indicating planar mode of failure. It is therefore concluded that along this portion of the highway planar or soil-like failure is likely to occur. The rosette (Fig. 7.8d) shows complex deformation leading to folding and high degree of shearing of the rocks.

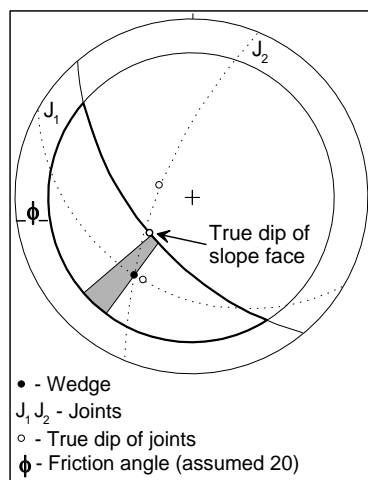
Fig. 7.9c. Stereogram

Two sets of joints are found to lend instability to the slope. The figure shows the development of a distinct wedge due to the intersection of these two joint sets. Both the true dips of these joints lie outside the shaded area. The intersection of J_1 and J_2 forms a double plane wedge. A rosette (Fig. 7.9d) data indicates F_1 folds and possible tensile fractures affecting the rocks.

- i. Reduction of slope angle in the upper soil horizon and removal of 3 m of the top soil is recommended (Fig. 7.9e).
- ii. A geotextile cover and grass plantation on the excavated soil will greatly help.
- iii. About 100 m length of the rock section treated with GI wire netting will provide stability to the slope.
- iv. Proper roadside drainage and maintenance is necessary.

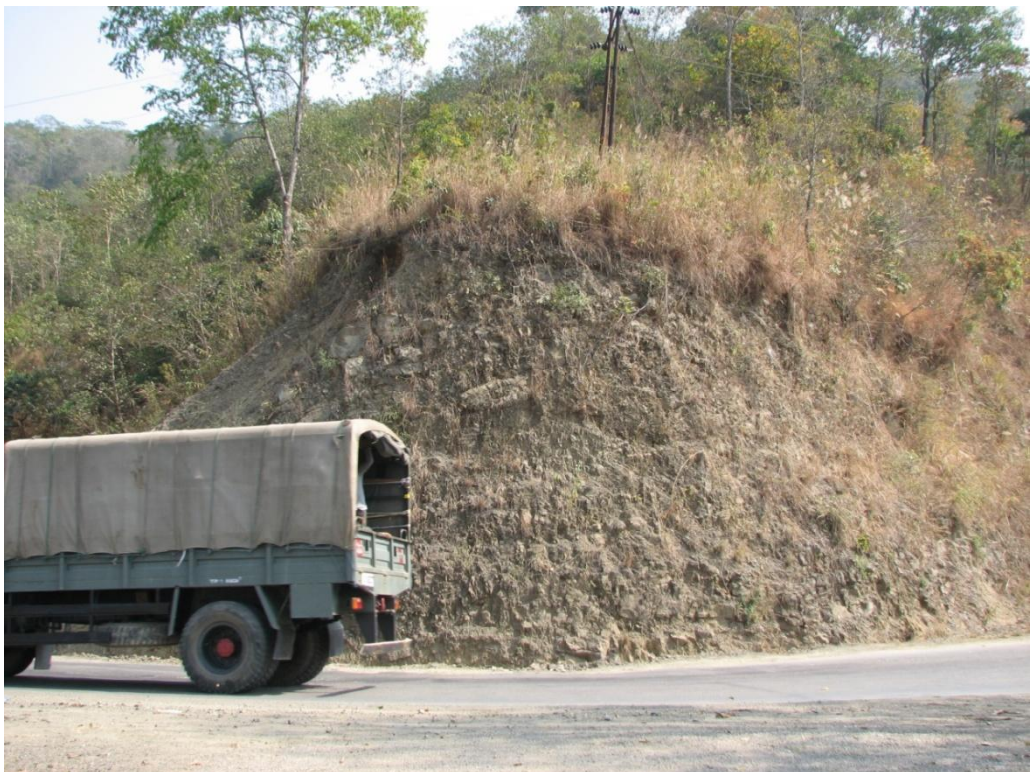
Plate 7.10b. Blind bend

This area located at 25°44'18.08" N latitudes and 94°05'1.05" E longitudes, is part of SoI toposheet no. 83 K/2 NW. This location (Fig. 7.10) was affected by minor but continuous debris slides (Plate 7.10a). Accidents are also likely as this area is a sharp and blind bend (Plate 7.10b).

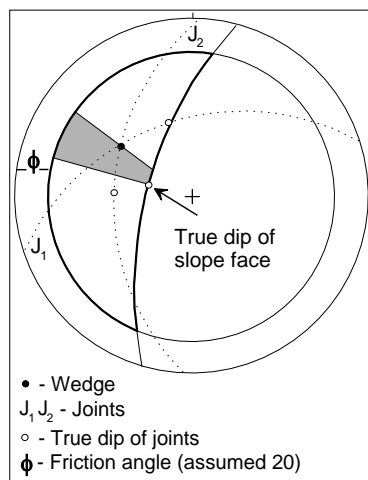
Fig. 7.10c. Stereogram

The stereographic projection shows the development of a distinct wedge due to the intersection of these two joint sets. The true dip of both J_1 and J_2 lie outside the slide envelope (Fig. 7.10c). Cruden (1978) suggests double plane wedge failure in such cases. The rosette (Fig. 7.10d) suggests complex deformation including shearing of the rocks.

- i. The free face of the slope is steeply inclined hence, benching is recommended to increase stability (Fig. 7.10e). The following are the proposed parameters:

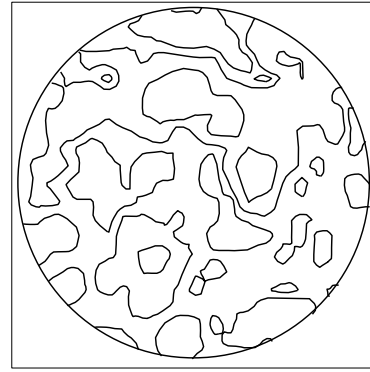
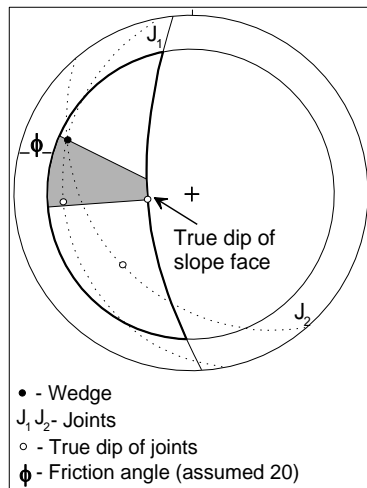
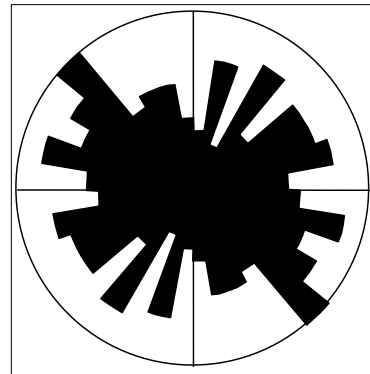
True dips of joint planes J_1 and J_2 lie outside the shaded region. It is therefore concluded that double plane wedge failure is likely to occur here where wedges will be large. Analyses of joint intersections (J_1 and J_2) indicate that wedges form small blocks in the rocks. Deformation in this location will primarily be of sheared nature (Fig. 7.11d) with other complex deformation.

- i. The top of the ridge should be trimmed to about 5 m for a length of 100 m (Fig. 7.11e).
- ii. Electric poles on the ridge crest should be relocated.
- iii. A reduction of slope gradient is recommended.
- iv. A cover of grass along the modified slope will lend stability to the slope.
- v. Proper maintenance of the roadside drain is required.

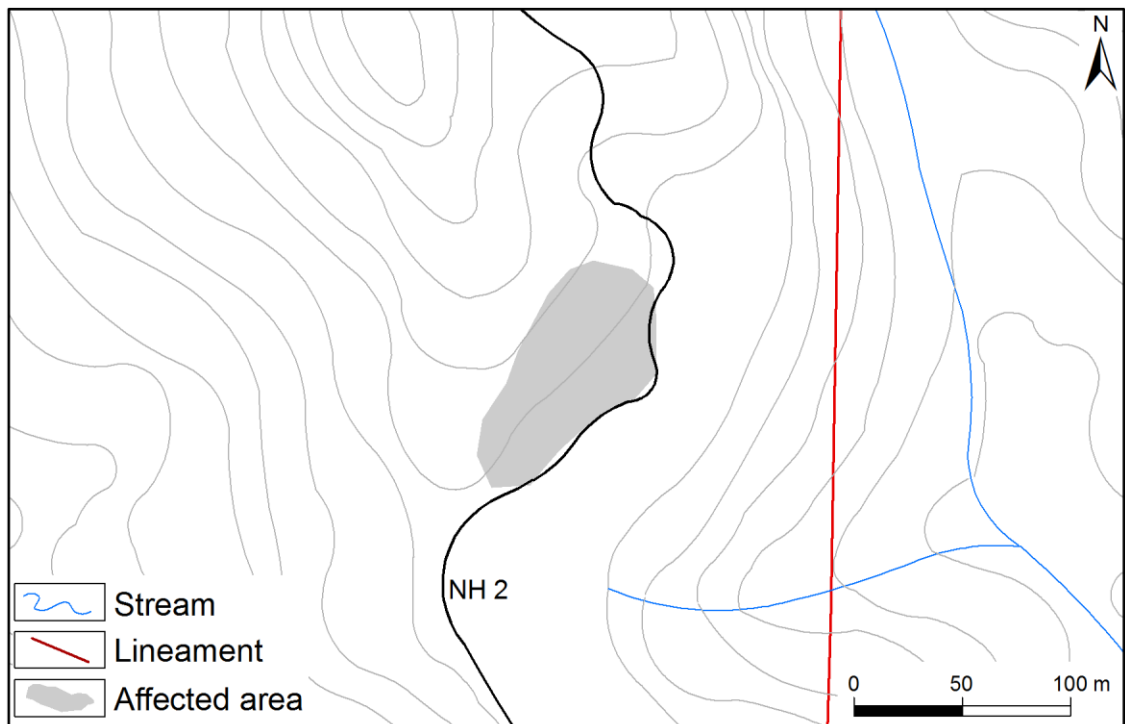
Fig. 7.12. Map of location 12

This debris slide is located at 25°45'36.21" N latitudes and 94°04'41.81" E longitudes and is part of SoI toposheet no 83 K/1. This is a steep slope along which a debris slide took place in the monsoon of 2007 (Fig. 7.12). The portion of the slope face above the highway is unstable (Plate 7.12a) and has affected about 120 m of the road.

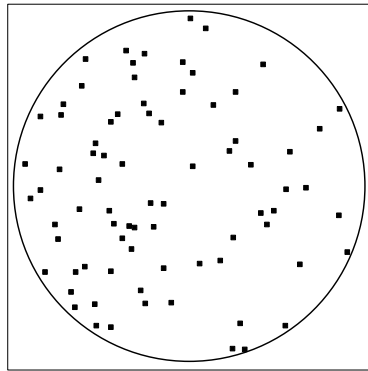
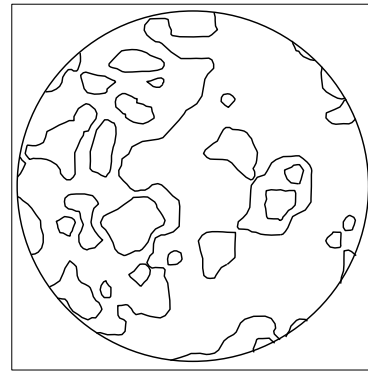
Kinematic analyses have been performed using about 165 joint attitudes that are plotted in pole (Fig. 7.12a) and contour diagrams (Fig. 7.12b), from which three joint sets ($J_1: 47^\circ \rightarrow 143^\circ$, $J_2: 65^\circ \rightarrow 75^\circ$, and $J_3: 47^\circ \rightarrow 114^\circ$) affecting the rocks are identified. These joints are plotted against slope attitude ($75^\circ \rightarrow 160^\circ$) in a stereographic projection (Fig. 7.12c).

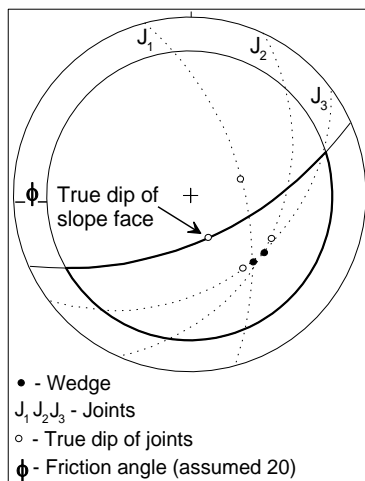
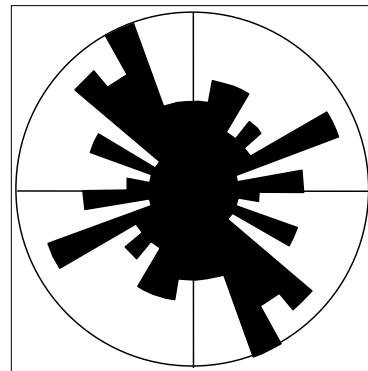
The diagram shows the development of two distinct wedges due to the intersection of these joint sets. The intersection of J_1 , J_2 , and J_3 forms a number of wedges. It is inferred that single plane wedge failure will occur as the true dip of one of the joint planes lies in the slide envelope. J_1 plotted against slope shows probable planar failure. Therefore, any slope failure will involve both planar and wedge types. The rosette constructed from joints (Fig. 7.12d) indicates extensive shearing, particularly antithetic, of the rocks besides tensile fractures and folding.

- i. A cantilever wall with the following specification along the toe of the slope is recommended (Fig. 7.12e).

Height - 2.5 m
Length - 120 m

- ii. Drainage of subsurface water through perforated pipes is necessary to prevent buildup of pore pressure.
- iii. It is also advisable to trim 4 m of the ridge crest.
- iv. The drain at the base should be regularly maintained.

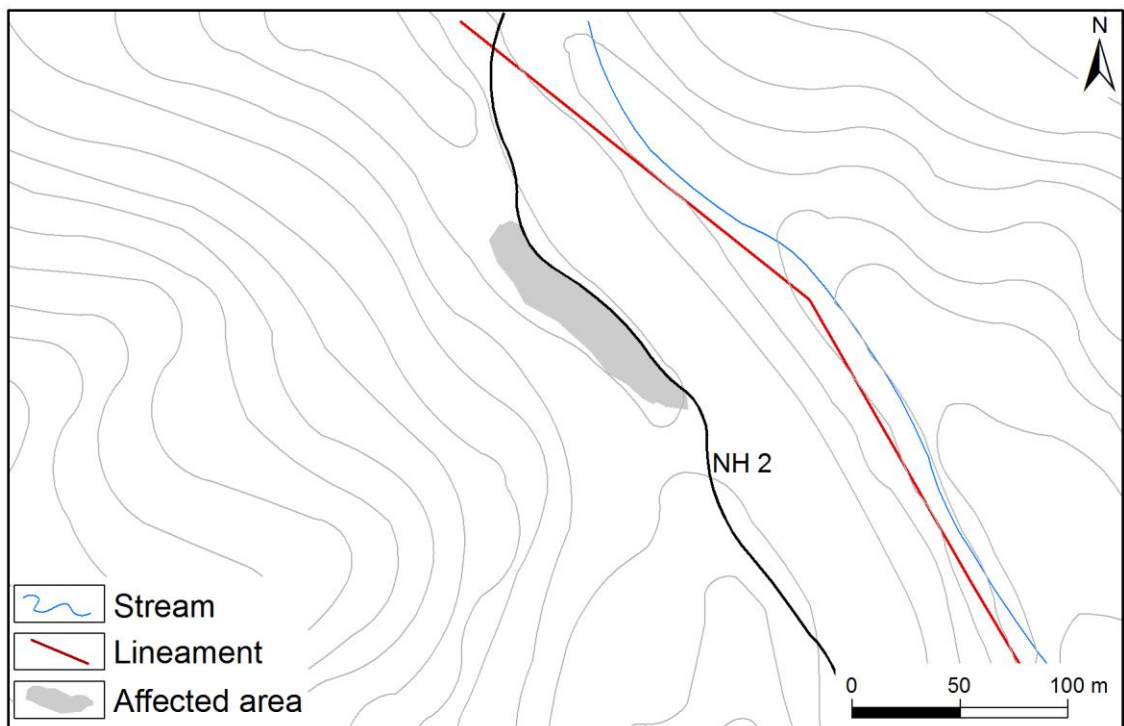
Fig. 7.13. Map of location 13

This area located at $25^{\circ}44'51.97''$ N latitudes and $94^{\circ}04'36.71''$ E longitudes, is part of SoI toposheet no. 83 K/2 SW. A very high and steep slope has been left due to road widening (Fig. 7.13). This section is very dangerous for a length of about 110 m for vehicular movement along the road (Plate 7.13a). The opposite side of the road is also dangerous due to weak material that has led to subsidence of portions of the highway (Plate 7.13b).

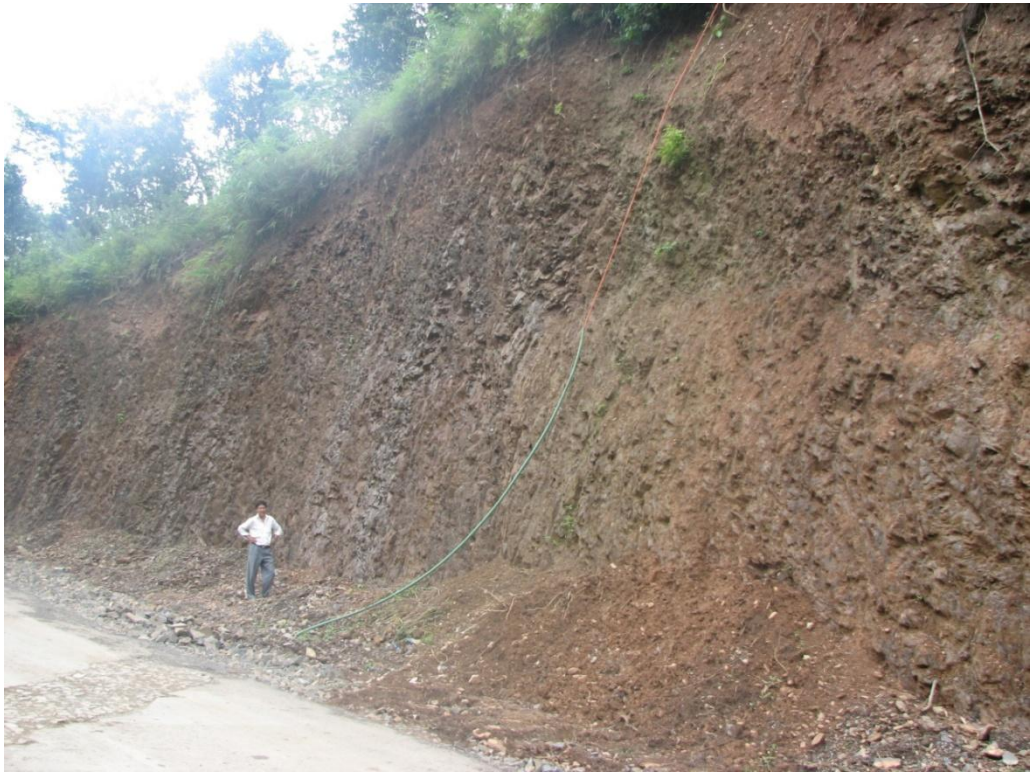
Plate 7.13a. High and steep slope

Road widening has left the slope as high as 12 m with an average inclination of 80°, without any support. Highly jointed shales exposed on such unfavorable slopes are susceptible to collapse. The poor drain constructed along this section of the road is always completely blocked by debris. The waters flowing over to the other side of the road saturated the lower slopes leading to the development of tension cracks and causing subsidence of the road.

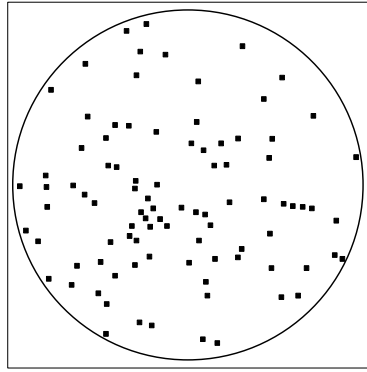
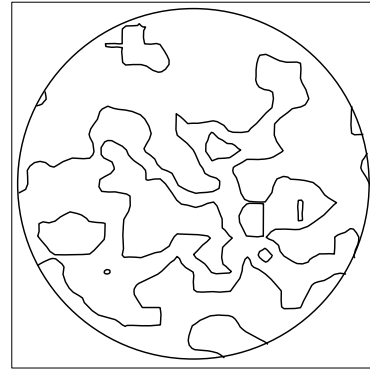
175 joint attitudes are used for kinematic analyses. Three sets of joints as deciphered from pole (Fig. 7.13a) and contour diagrams (Fig. 7.13b), which point to possible instability of the slope material.

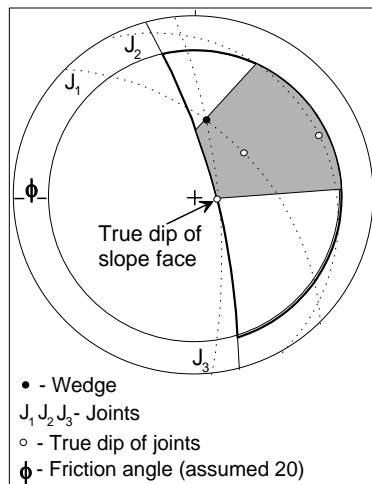
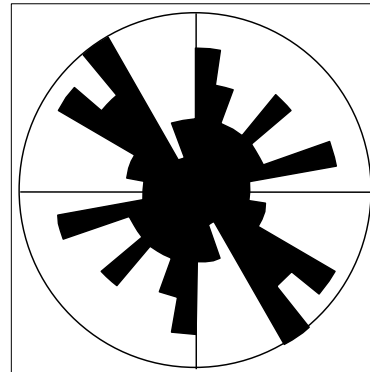
The stereographic projection (Fig. 7.13c) shows development of both wedge and planar failure which are inferred from the intersection of the joint sets. One of the true dips of the joint planes lies within the shaded region between the true dip of the slope and the line of intersection of the two joint planes. Planar and/or wedge failure are likely to occur along this portion of the highway. Analyses of joint intersections indicate that wedges form small blocks in the rocks; joint 3 will cause planar mode of failure. The rosette (Fig. 7.13d) indicates high structural deformation including tensile fractures.

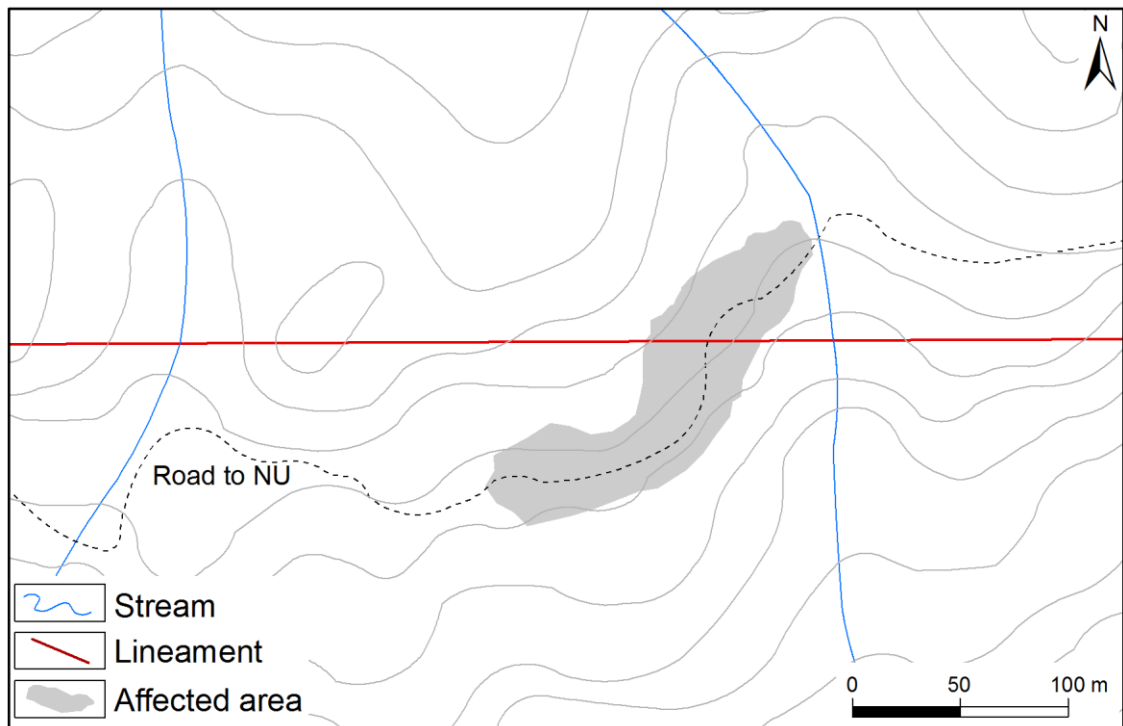
Fig. 7.14. Map of location 14

The location is part of SoI toposheet no. 83 K/2 NW that is located at $25^{\circ}43'26.25''$ N latitudes and $94^{\circ}05'29.26''$ E longitudes. The road leading to the Nagaland University Campus (Fig. 7.14) is scarred by a debris slide and subsidence due to road widening. The slope had been cut and left untreated which is the reason for the instability.

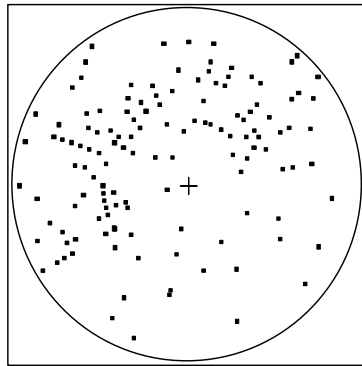
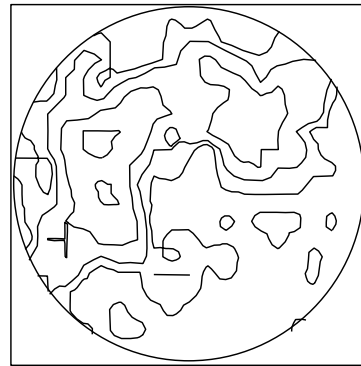
Kinematic analyses have been performed for determination of possible mode of failure. About 150 joint attitudes are taken and plotted in pole (Fig. 7.14a) and

contour diagrams (Fig. 7.14b) from which two joint sets affecting the rocks are identified.

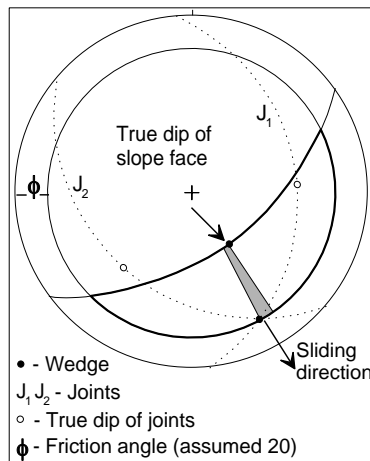
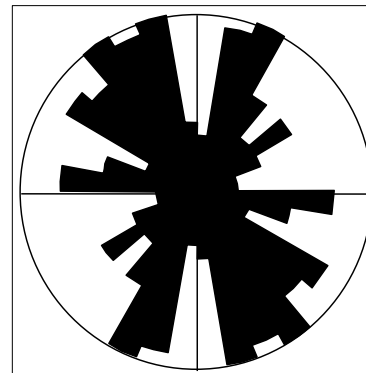
These joints are plotted against slope attitude in a stereographic projection (Fig. 7.14c). The diagram shows a distinct wedge due to the intersection of joints J_1 and J_2 . Cruden (1978) suggests double-plane wedge failure in such cases as both the true dips of the two joints lie outside the shaded area. Development of planar failure cannot be ascertained as none of the strikes of joints have a parallelism value of $\pm 20^{\circ}$ against the strike of the slope as opined by Hoek and Bray (1981). Field observations also rule out planar failure. The rosette (Fig. 7.14d) indicates extensive shearing and folding of the rocks, and possibly the action of a thrust.

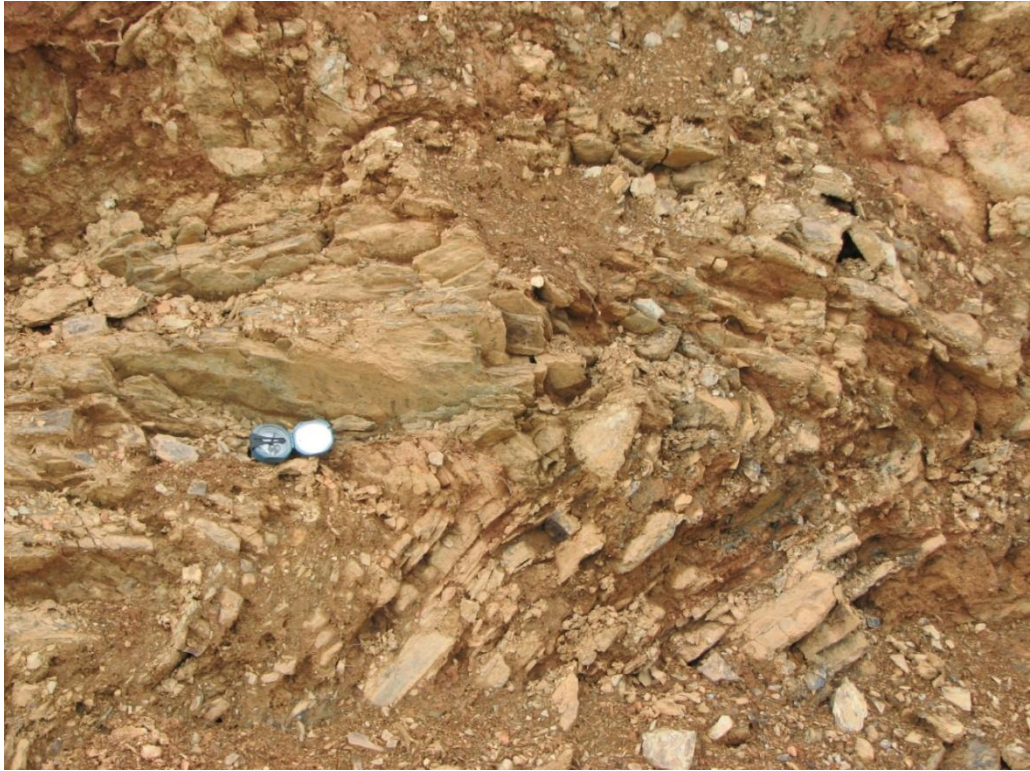
Structure and lithology are the main geologic factors contributing to slope instability in the area. These rocks are commonly affected by local folds (Plate 8.1) and are cut across by two to four sets of joints. Thrusts too are probably present in the Disang. However, due to the monotonous nature of the Disang sediments it is difficult to map such thrusts. Joints, shear zones, fault planes, and weathered horizons in this area facilitate erosion, particularly with the aid of surface runoff. Surface runoff is responsible for removal of most top soil. The joints are responsible for imparting the splintery nature to some of the Disang shales (Plate 8.2). The shales in this area are highly fissile, which is another cause of their weakness. The fissile nature of the shales coupled with the joint planes have made this terrain highly susceptible to mass wasting. Folding and faulting in the area have crumpled and fractured the shales to a great extent (Plate 8.3). These crushed zones comprise debris of various materials that are thoroughly mixed with clayey and sandy soils.

Plate 8.1. Folding in shale

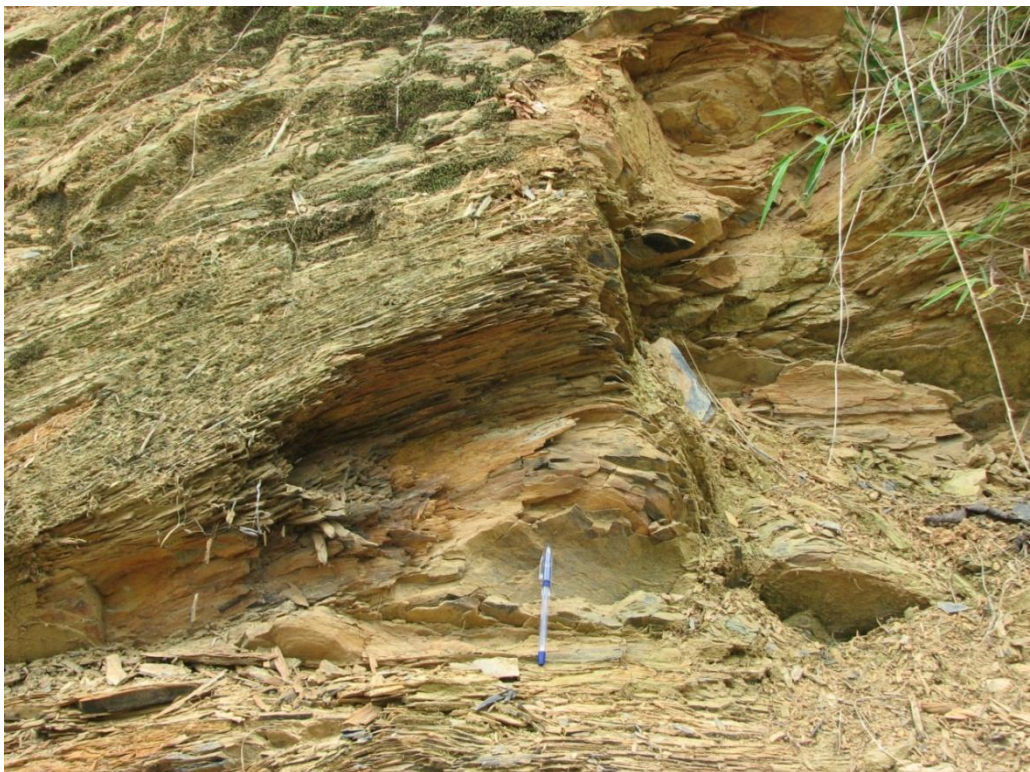
Plate 8.2. Splintery Disang shale
